## **CHAPTER 2**

### **DATA**

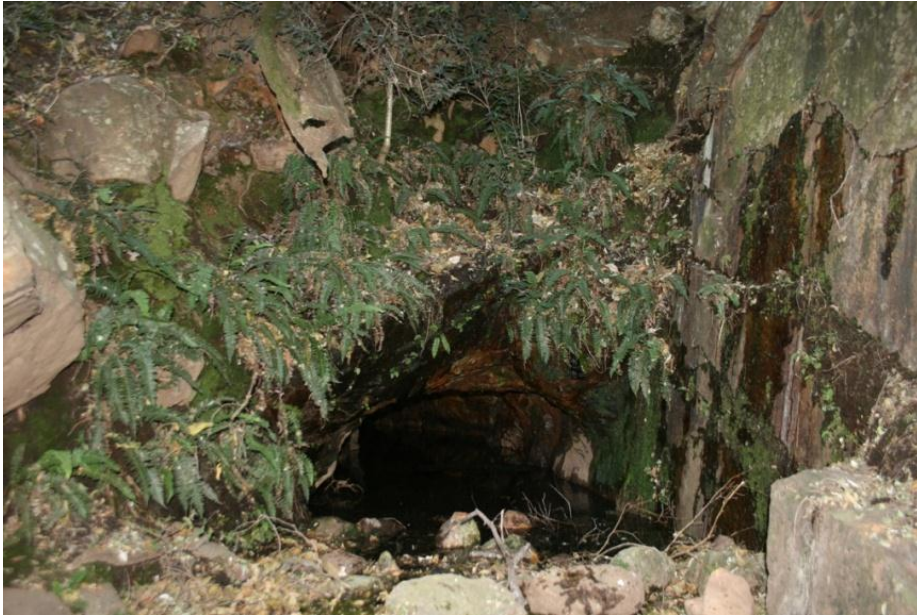
Figure 13. Adit, B8, with dangerous overburden and filled with water on the eastern portion of Buffelskloof 511IQ.

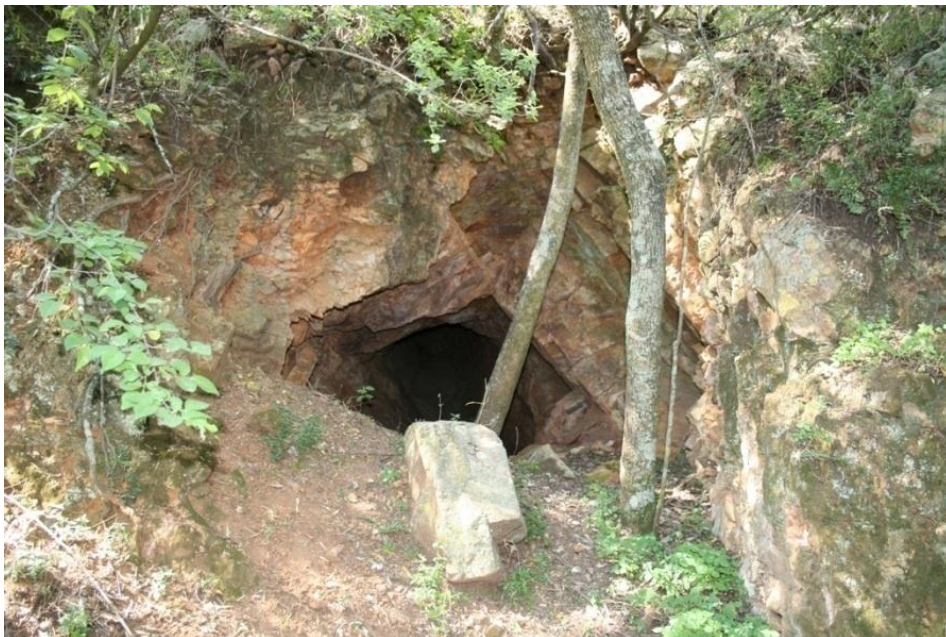
B9 is an open adit which appears to have a holing resulting in through ventilation in the mine. The adit hanging wall and overburden are unstable and were not fully accessed (Figure 14).

Figure 14. Adit, B9, on the eastern portion of Buffelskloof 511IQ with dangerous overhang at the entrance.

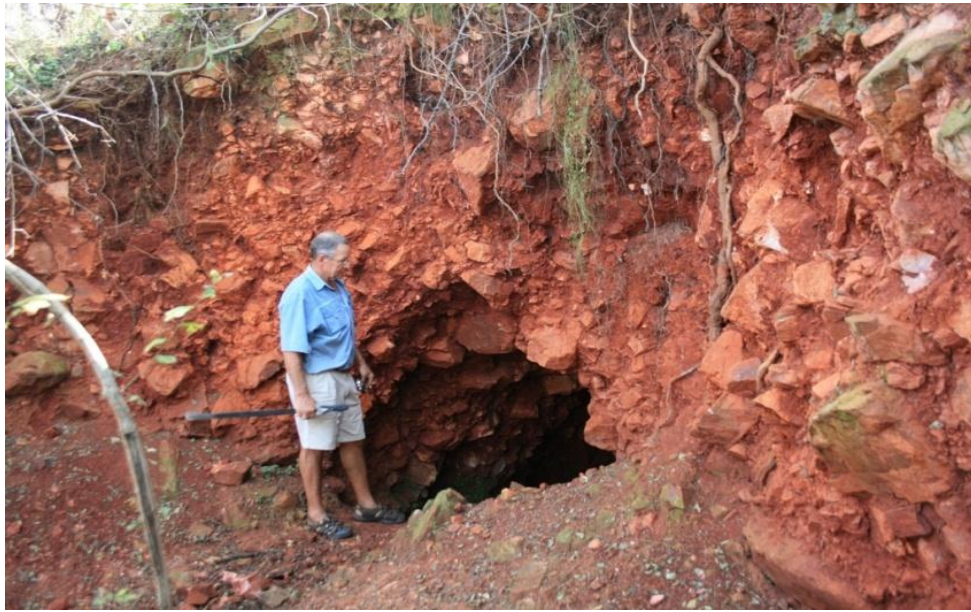
Although the mine, KL1, is visible from the road it is quite a distance from the road. The dense vegetation makes locating the adit very difficult. The hanging wall to the adit is very unsafe. This is due to the steep slope directly above the adit which consists of unconsolidated gravel and soil (Figure 25). Evidence of recent human occupation in and around the mine is of concern as it has a very good vantage point to the road. This concern is due to regular burglaries at dwellings in the area. The staff of the interim

Figure 25. The adit, KL1, on the Red Reef at Koedoeslaagte 516IQ. Note the dangerous condition of the overhang.

The adit, KL 1 (Appendices B and C), was found with great difficulty and since access to this specific reef is very limited this adit should be limited to scientific access only since there are only two sites where this reef was mined and are accessible, keeping the unstable overburden in mind (Figure 25).

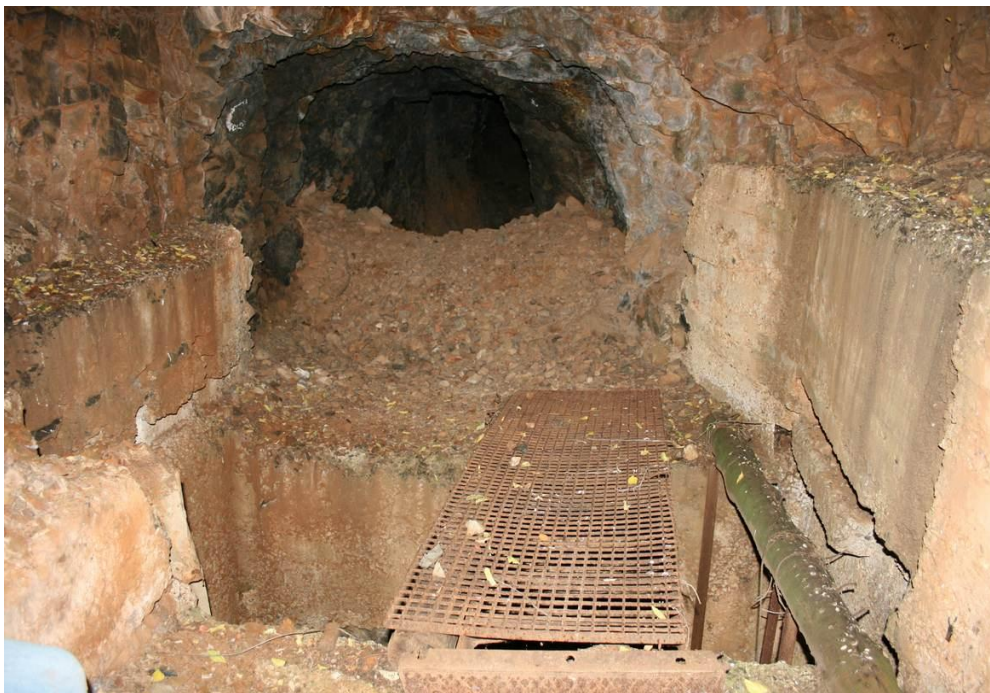
Figure 28. Underground infrastructure covering a water filled shaft and leading to an unventilated end at Rebokkop 290.

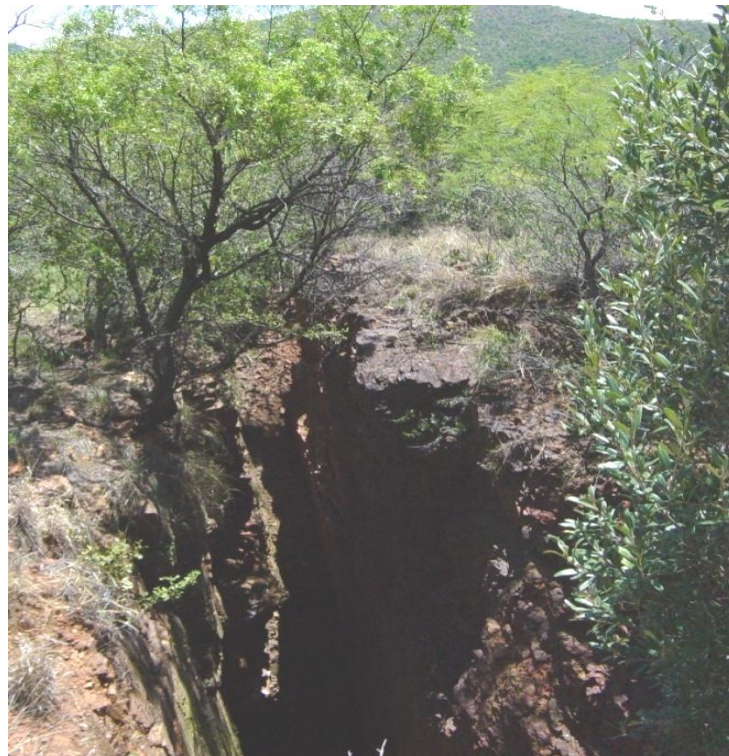
The mine consists of two stopes, a vertical shaft and an adit. The stopes are open to surface (Figure 29) and since it is unfenced it poses a safety hazard.

Figure 29. Slopes on Nooitgedacht 89 open to surface

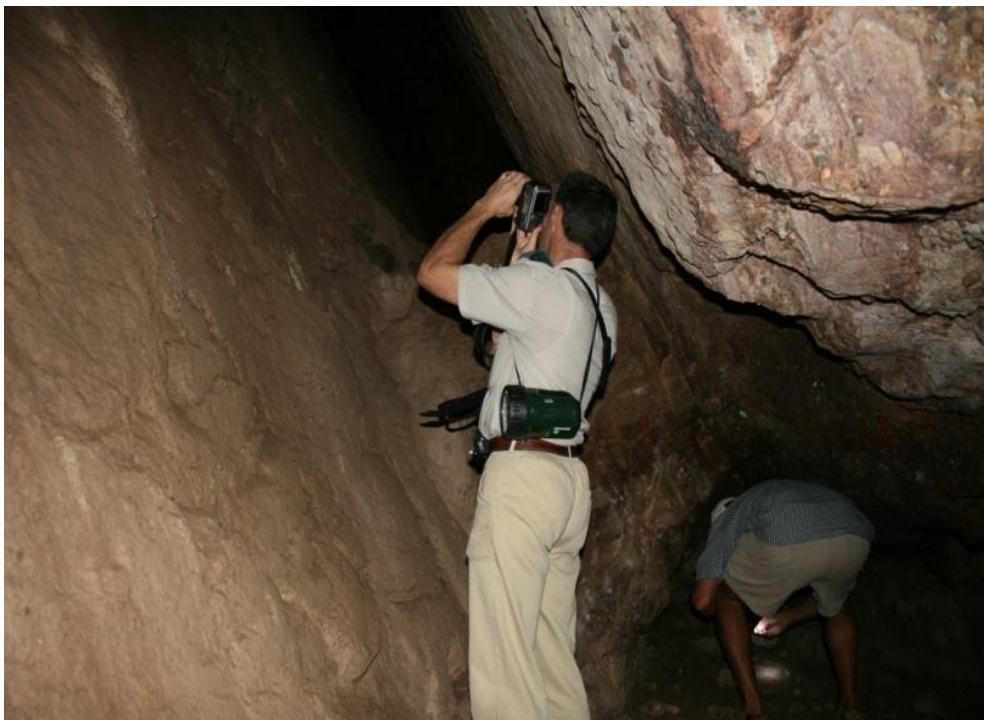
Figure 57. Near vertical stopes accessible from the side of the ridge at K3, Nooitgedacht 508 IQ.

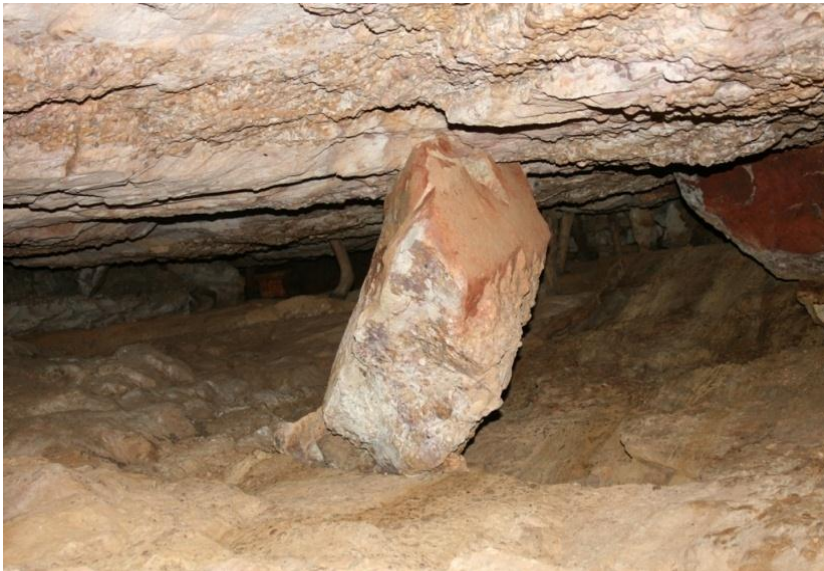
Figure 58. The same stope as in Figure 57, showing signs of collapse and crumbling pillars.

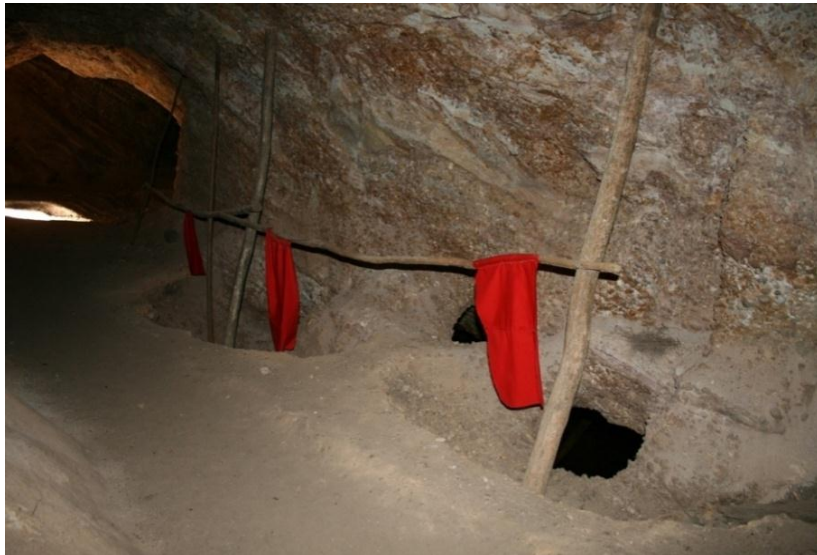
Figure 59. An adit at R19, Rooderand 510 IQ where the stoping from the bottom level holed into the reef drive. The red flags were used in an attempt to warn visitors of the danger when walking past the site after abseiling down from a raise holed to surface (where sunlight enters to the left hand side of the picture).

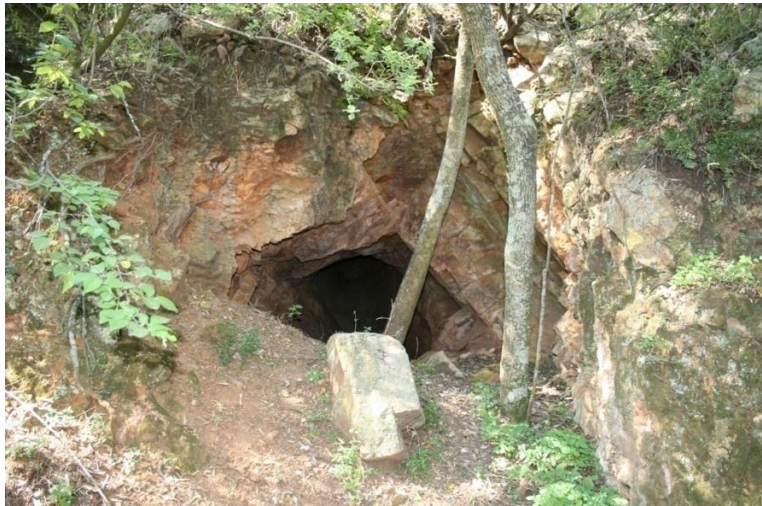
Figure 60. An adit QB13 on Buffelskloof 511 IQ with bad overhang at the entrance.

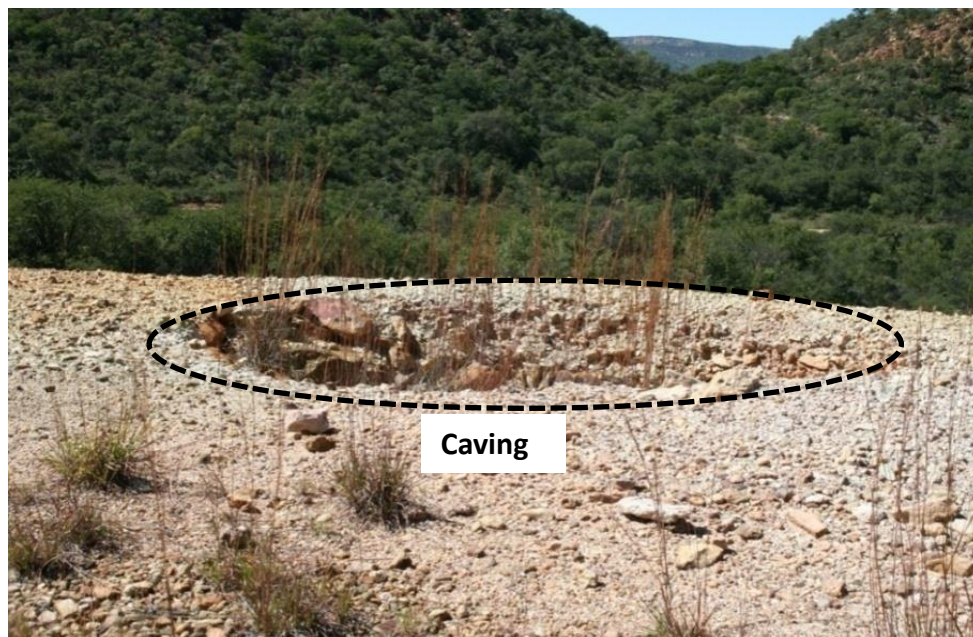
Figure 61. Rock dump, R15, on Rooderand 510IQ, displaying signs of caving.

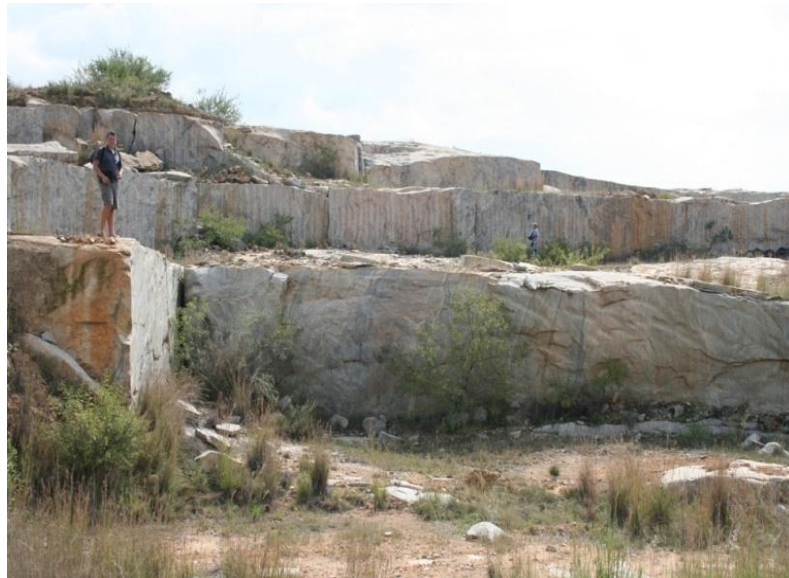
Figure 62. High quarry wall (approximately 4m) in Salvamento Quarry GQ2, Kopjeskraal 517IQ

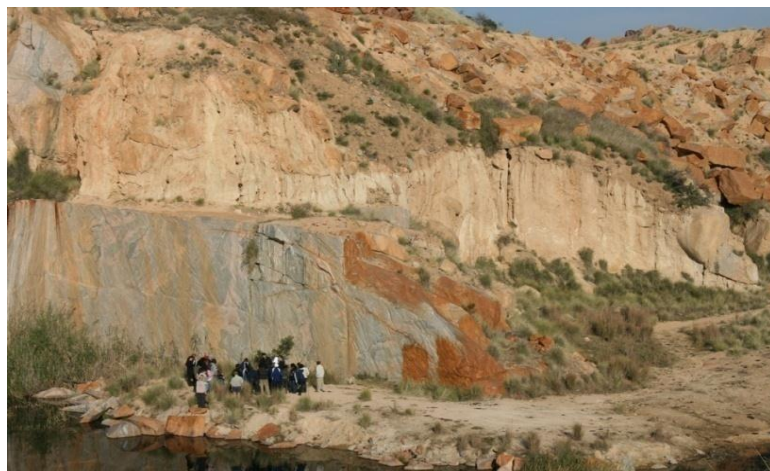
Figure 63. To the upper right of the group of people to the far right of the photograph unstable rock dumps and overburden at Leeukop Quarry GQ3 on Kopjeskraal 517IQ.

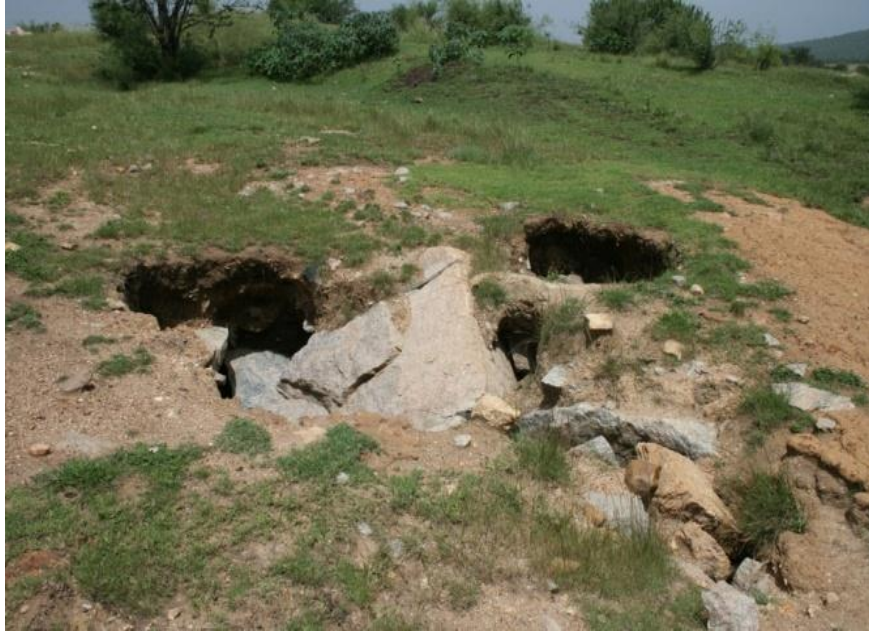
Figure 64. Caving observed at quarry GQ4, Rietpoort 518IQ

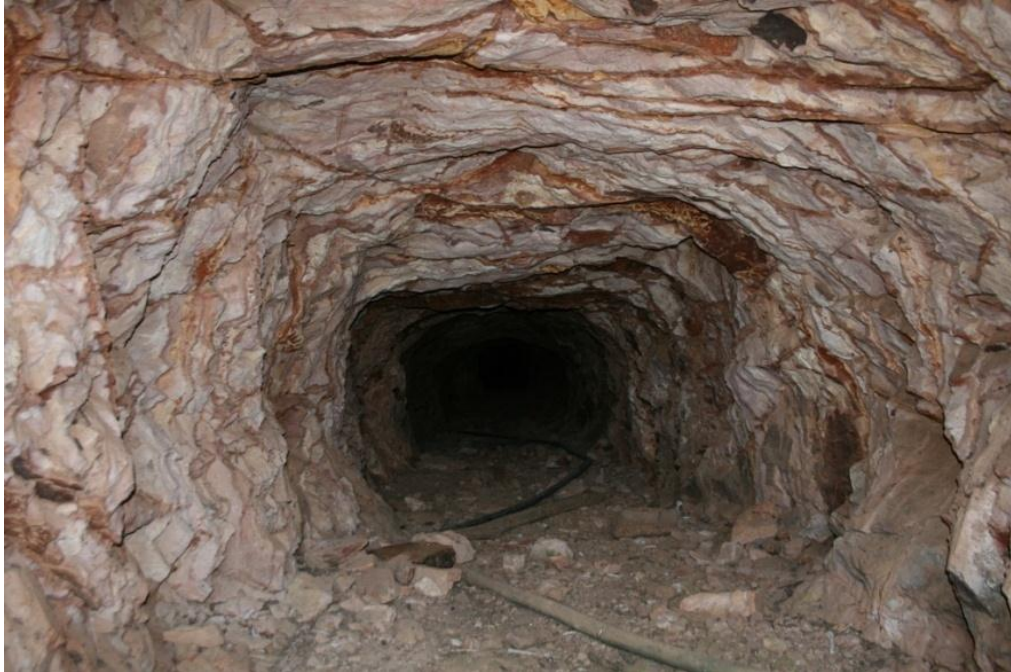
Figure 72. Looking down the decline, RO1, on Rooderand 510IQ. Of general concern is the presence of the plastic water pipes indicating extraction of water in the not too distant past.

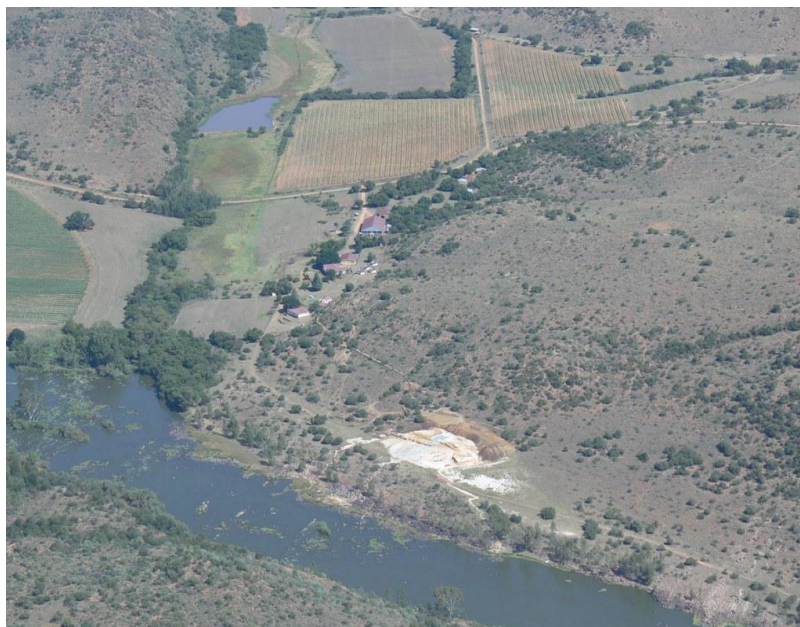
Of concern here is the tailings disposal facility (TDP), previously called slimes dam, which is eroding and depositing material into the Vaal River (see Section 3.3.2). The adit and shaft observed were not fenced off and the shaft particularly poses a threat to visitors due to the steep walls. Remains of the cement platform possibly used for the

Figure 73. The erosion of tailings slimes into the Vaal River at Great Western Mine, E1, Elandslaagte 28.
