A comparative evaluation of two rehabilitation options employed to rehabilitate industrially generated elemental seepage on a coal mine

Dissertation submitted in fulfilment of the requirements for the *Masters* degree in *Environmental Sciences* at the North-West University

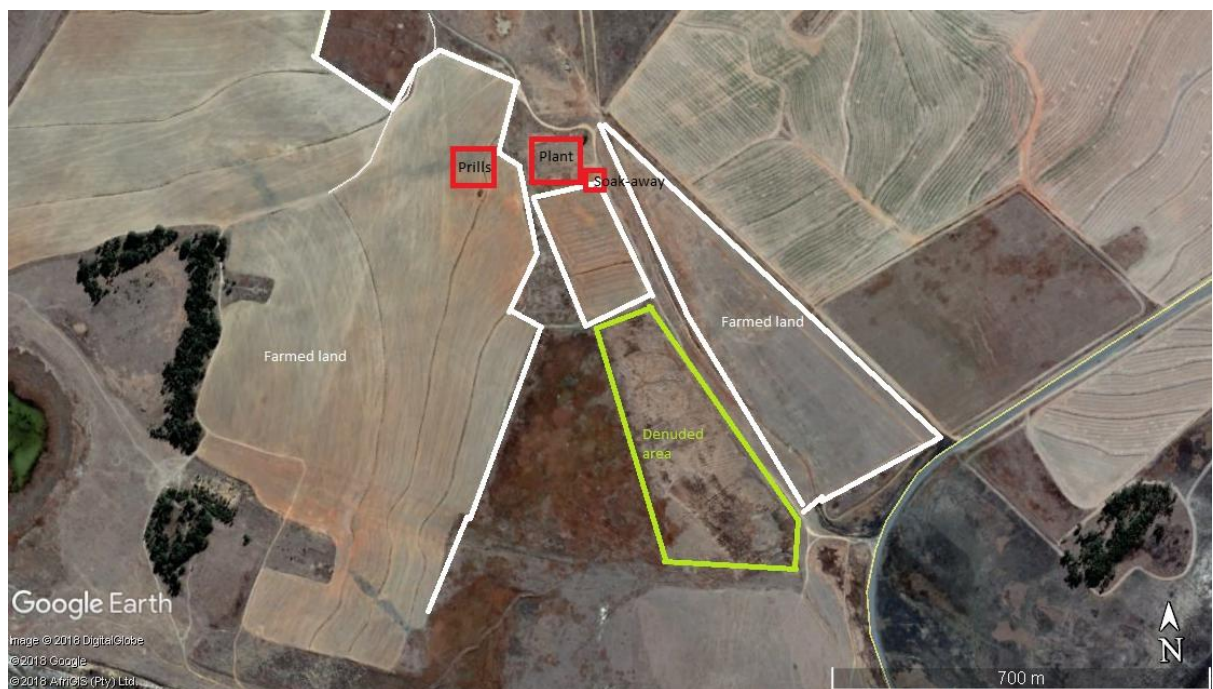
Figure2.2: A site map illustrating the different sections of the study area.

To the east of the mining site we find where the old explosives manufacturing plant was situated on top of a watershed with the denuded area downslope to the south of the plant as illustrated in figure 2.2. The site is divided into different sections (Figure 2.2) namely:

- i) The plant or plant footprint: This is where the plant was situated when it was still in production.
- ii) The prills silo: Situated to the west of the plant on the area where the storing facilities was situated before decommission of the plant
- iii) The soak away: Placed just south of the plant where disposal of effluent and wash water took place
- iv) The denuded area: To the South of the plant below the farmed field. This area is where the contaminants affected the soil and caused the denudation of vegetation.

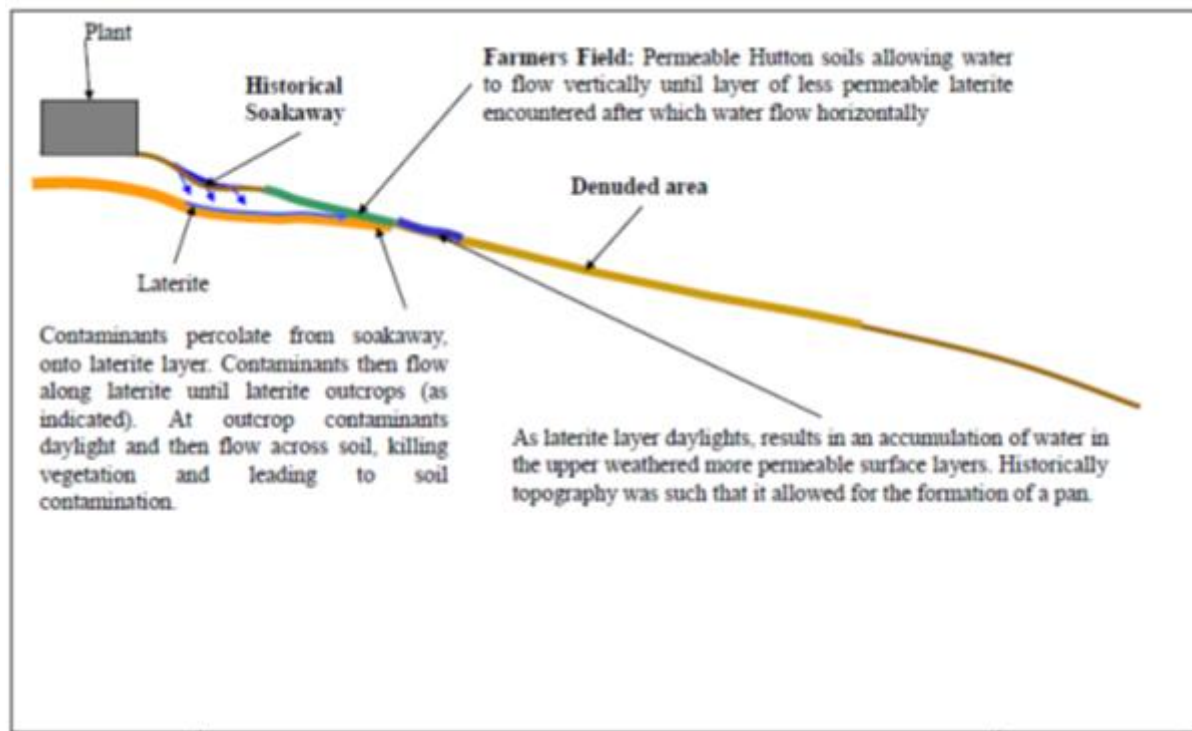
Figure 2.4: The first rehabilitation company's understanding of underlying geology.

RC1 evaluated the denuded area and stated that, from their historical knowledge of the practices in the area, the main sources of pollution were the old soak-away and the excavation at the prills silo. The company constructed a conceptual model of the area that shows the laterite layer below the surface and the area where the pollution daylights. Based on this conceptual model of the underlying geology they assumed that the pollution entered the soil through shallow seepage, mostly in the area where the old soak-away was situated, and moved below the soil surface on the laterite layer under the farmers field to the point where it daylights at the top of the denuded area.

With the above mentioned perception of the underlying geology thought to be present in the area RC1 constructed two cut off trenches (1000mm in width at a depth of 2000mm) on the farmers field in order to intercept the pollution between the source (old soak-away) and the denuded area. This was done to reduce the ongoing pollution of the denuded area and these two connected trenches drained into a holding tank (10m³). The local farmer emptied the tank once every week and used the content as fertiliser.

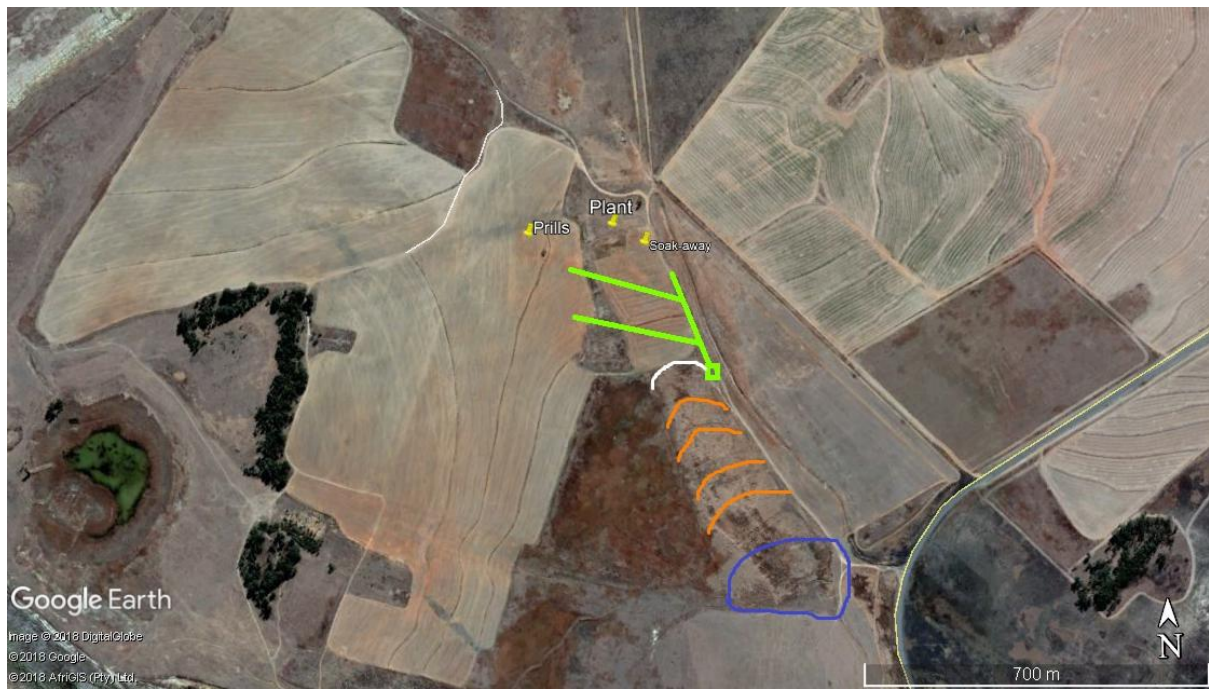
Figure 2.5: Physical rehabilitation measures illustrated on the site map with the RC1 drainage channels in green and contour berms in orange.

Other rehabilitation procedures were also implemented on the denuded area at the same time. These procedures entailed ripping the area to a depth of 500mm to enhance the permeability of the soil for better leaching conditions and the ripping against the contour created an irregular surface that reduced surface runoff (less erosion) and increased the amount of water that infiltrated the soil. This also created a physically suitable growth medium for plants to establish.

After the area was ripped, compost was added together with a freeze-dried bacteria culture to the denuded area. Contour berms of 300mm in height were also constructed at regular intervals over the denuded area. This was done in order to reduce surface runoff and increase the amount of water that infiltrated the soil. Thereafter, the area was seeded with a number of pasture species namely *Eragrostis curvula* (Making up 40% of the total seed mix); *Eragrostis tef* (Tef); *Digetaria eriantha* (Smuts Finger Grass); *Chloris gayana* (Rhodes grass). Seed mix was to be applied at 50kg per ha.

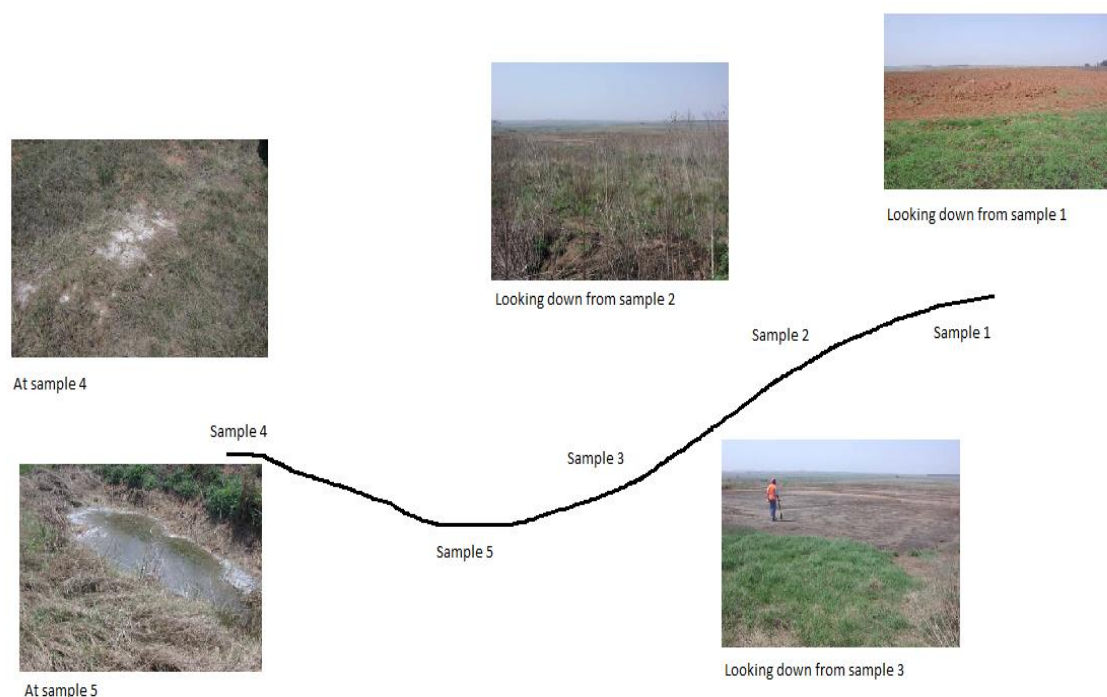
Figure 3.1: Cross section display of where the first five samples were taken during the initial site visit in 2010.

Five samples were collected on the historical sample sites (one on each). These soil samples were taken from the plant footprint, the old soak-away, the footprint at the prills silo, $\frac{1}{4}$ of the way down slope on the denuded area and $\frac{3}{4}$ of the way down slope on the denuded area. The rationale behind this was to determine the overall state of the site in terms of soil chemistry and pollutant levels in order to get a better view of what the problems were that needed to be addressed. The reports from RC1 were made available in order to see what has been done and to make more informed recommendations. Figure 3.1 is an illustration of the sampled area and where the samples have been taken.

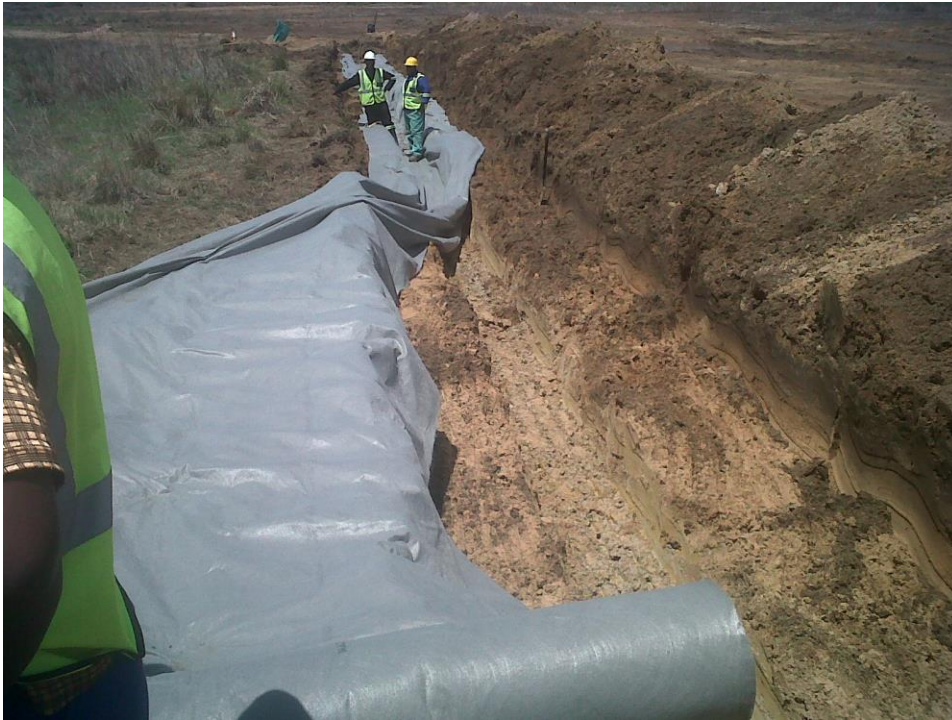
Figure 3.6: A photograph displaying the lying of Geofabric during construction of the drainage system.

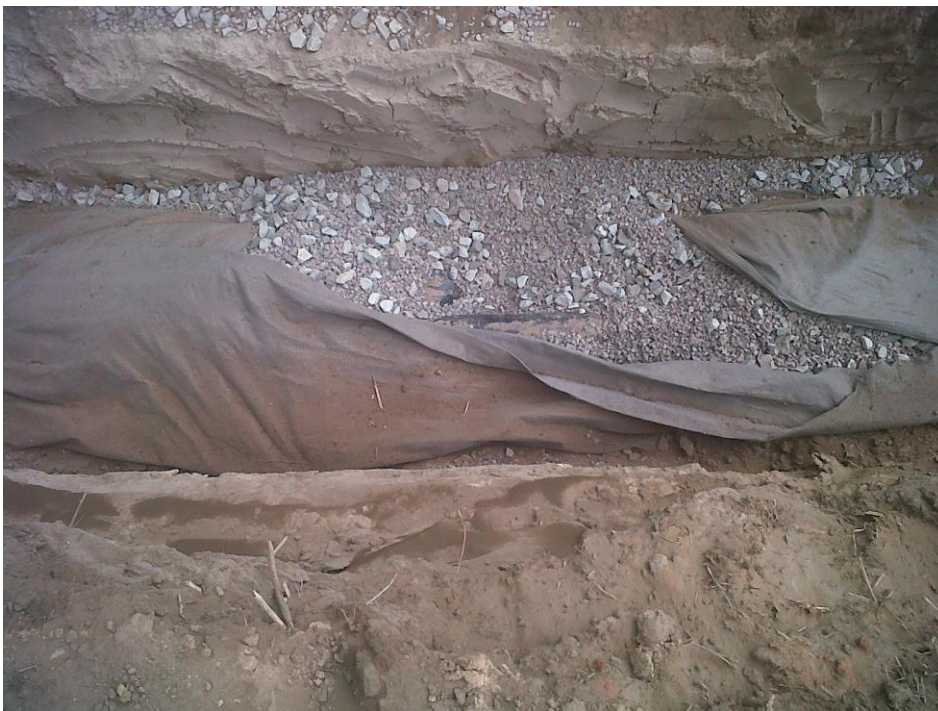
Figure 3.7: Imbedding of Geopipe during construction of the drainage system.

Deformation of Geopipe is not seen as a problem but rather a requirement. The correct placement of bedding and padding should be implemented so that the deformation of the pipe does not exceed the limits. The backfilling of the trench was done in a symmetric manner in order to prevent the lateral movement of the pipe as this can cause problems with alignment. No dumping of soil in an indiscriminate manner to backfill the trench was done because this would have a negative influence on the integrity of the pipe. Furthermore, rocks pressing against the pipe should be avoided.

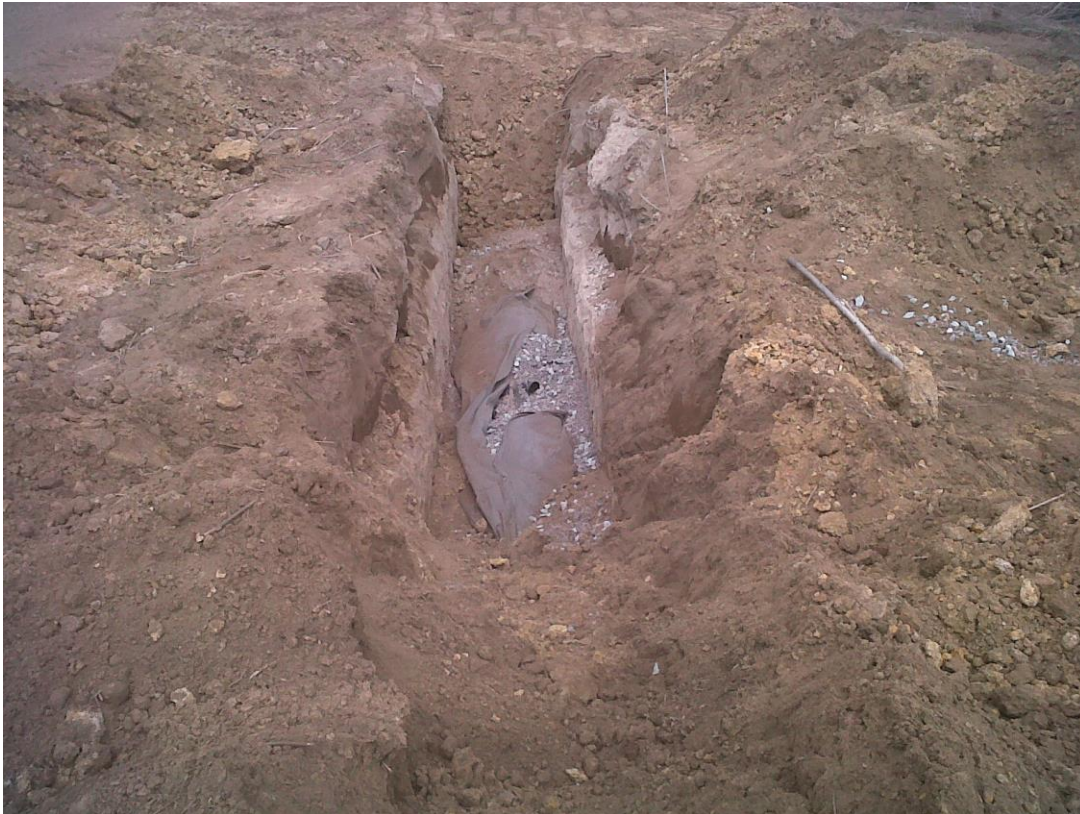
Figure 3.8: Backfilling of trenches after installation of drainage system.

A layer of selected aggregate was placed above the pipe for protection against rocks and to provide support for backfilling. Hand compaction was used on the first 300mm of medium above the pipe. The selected backfill specifications (SABS 1200: Earthworks) divided the material into two classes. Class 1 is a clean, crushed rock or stone aggregate in the range between 9 and 38mm with little or no fines (particles smaller than 0.075mm). Class 2 is coarse grained, granular, free-draining, non-cohesive soils graded between 0.6 and 38mm with less than 5% fines.

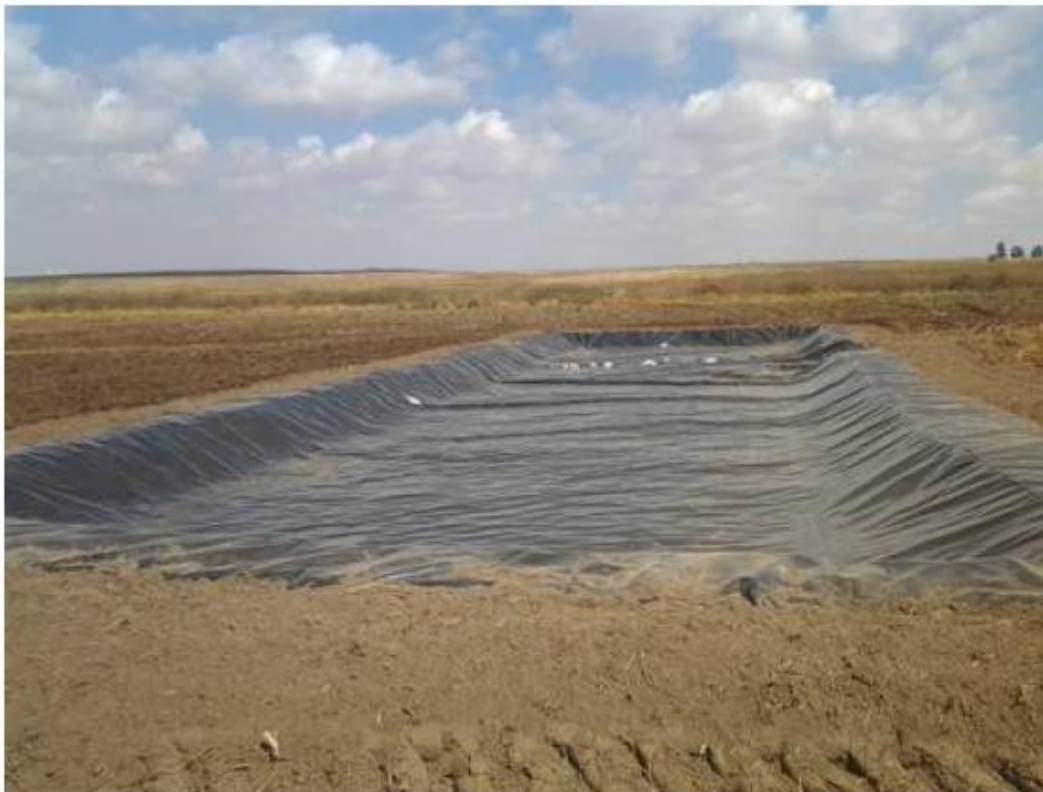
Figure 3.9: Completed evaporation pond with drainage pipes entering on the right.

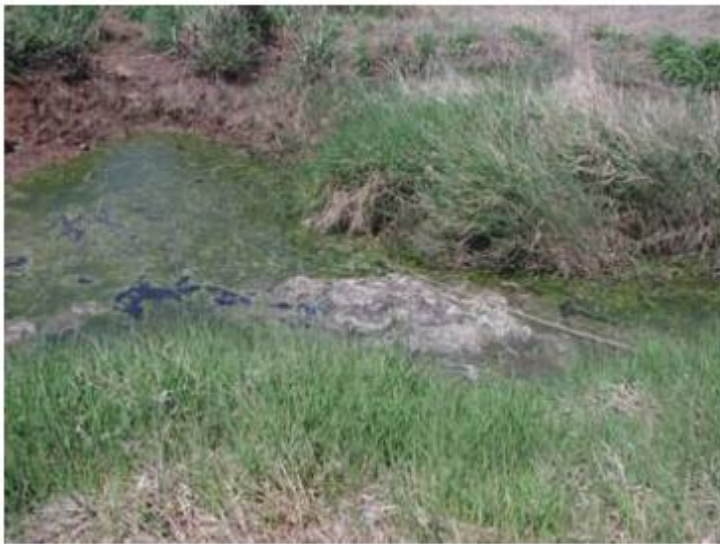
Figure 4.1: Visible Eutrophication due to the N leaching at the natural stream to the south of the denuded area. The stream is around 1.5m wide.

Sample 5 was taken at a pond in the natural stream at the bottom of the slope and showed a combination of chemical residue from the mining activities and the pollutants (fertilizer/explosives) leaching from the source at the top of the slope. Elevated Na, NO_3 , NH_4 Mn and Zn concentrations were seen in the analyses together with a low pH and a high EC value of 2.26mS/cm which should be 1.8 to 2.0mS/cm for plant establishment and growth. (Bergmann, 1992)

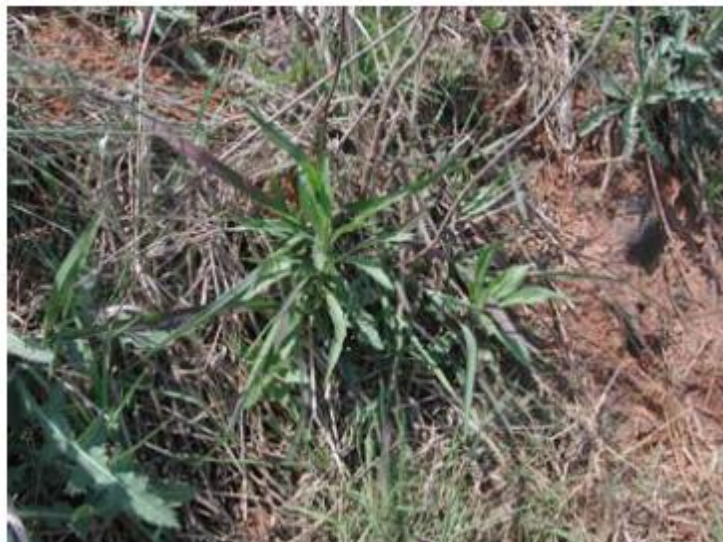
Figure 4.2: Vegetation producing anthocyanin due to salt and Mn load adjacent to the denuded area (east).

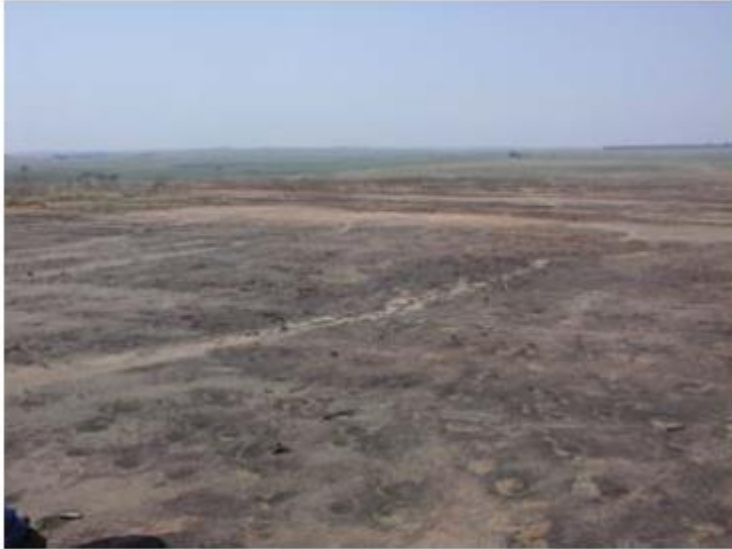
Figure 4.3: Visible signs of surface runoff and erosion on the denuded area.

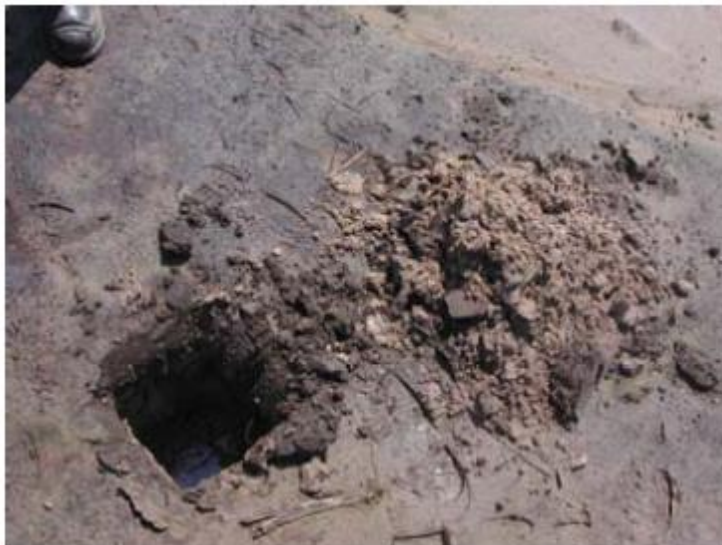
Figure 4.4: Very shallow water table on the denuded area close to the ¼ denuded sampling point due to saturation of the soil. (The size of the hole is 30 x 30 x 30cm).

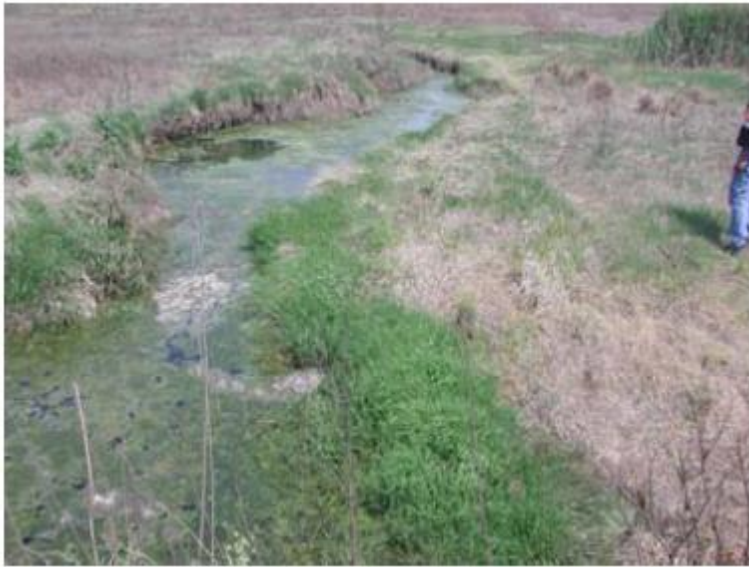
Figure 4.5: N pollution on surface at the natural stream down slope from the denuded area.

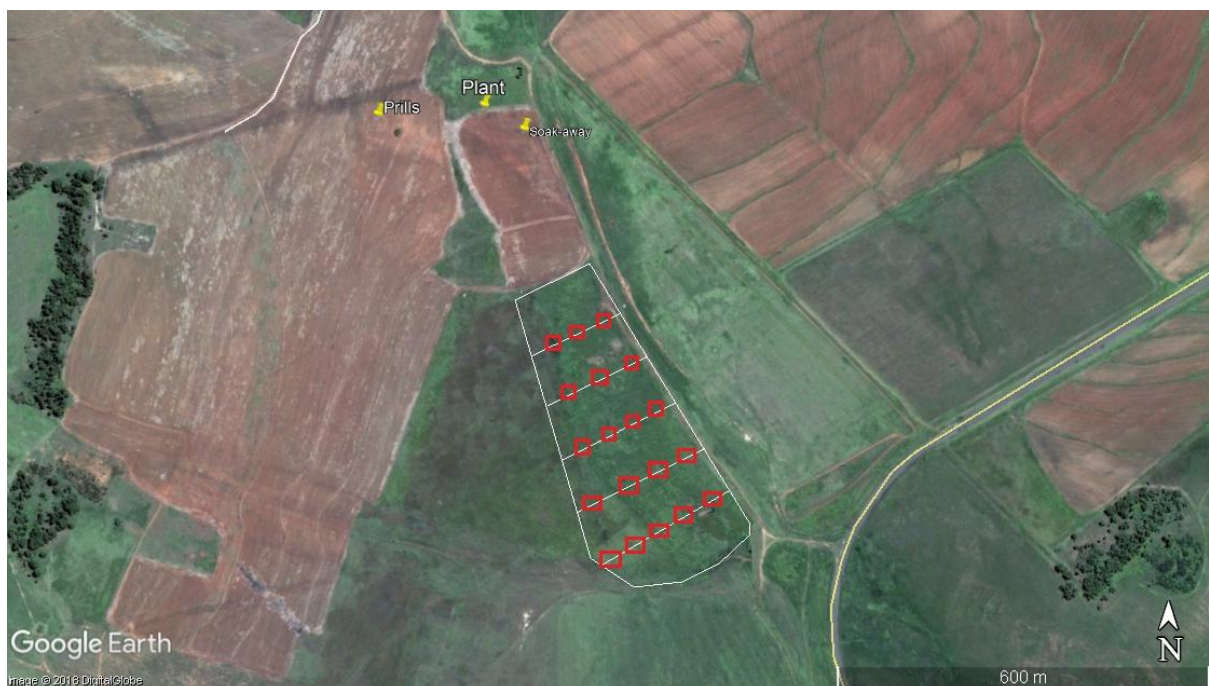
Figure 4.7: Map overview of the rehabilitated area (the white lines indicate the transects numbered 1 to 5 from North to South and the red blocks indicate the quadrants numbered from 1 to 5 from the East to the West).

Due to the fact that the sample sites at the plant footprint, prills silo and old soak-away were used for crop production by a local farmer; the area was not seeded with the prescribed seed mix, however, the amelioration was implemented. The vegetation assessment was done in September 2016. This assessment included only the previously denuded Transects, which were numbered from 1 to 5, starting from the farmers field (up-slope) and moving down to the natural stream. Figure 4.5 indicates the transects and each quadrant on them:

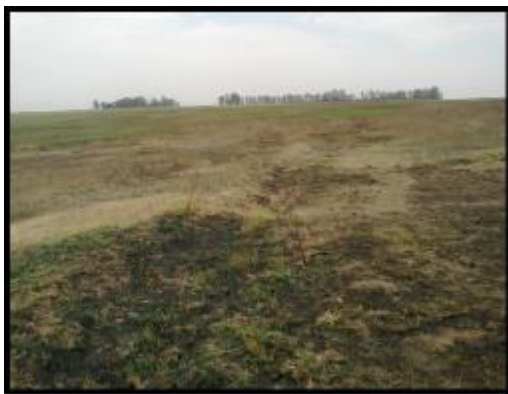
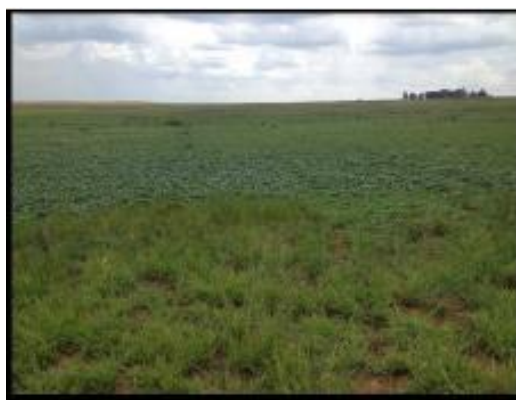
Figure 5.2: Photographs taken before the implementation of the rehabilitation procedure (on the left) and 1 month after seeding (on the right).

The soil prior to rehabilitation showed substantial areas, completely denuded of all vegetation. This was especially noticeable after large amounts of rain that caused contaminants to enter these areas. The soil was an abiotic medium with characteristics like poor or no structure and with erosion problems all over the surface. The little vegetation found on some spots of the site during this time was clearly struggling for survival and could be described as sparse. Figure 5.2 displays

One month after seeding the area the site changed significantly. Broad leaf weeds were present throughout the site, however, the intended species were also present in large numbers. Weed control was implemented, but this step will have to be repeated at a later time. In Figure 5.3 the transformation is seen from a site denuded from all vegetation to a vegetated landscape.

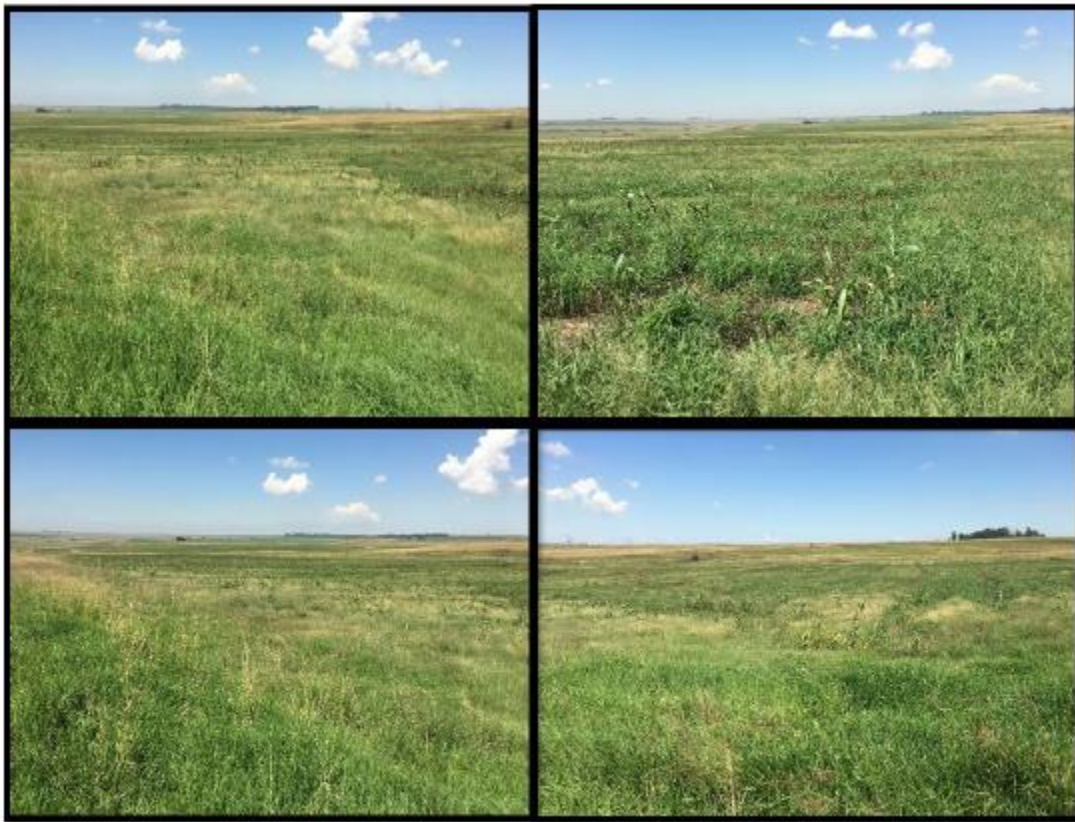
Figure 5.3: Photos taken 3 months after seeding on the previously denuded area.

After 3 months the vegetation cover showed a significant increase in planted pasture species in spite of the drought that caused lower than average rainfall in the region and higher than average daily temperatures.
