**REDUCING THE POTENTIAL FOR ACCIDENTS AND THE
ASSOCIATED ENVIRONMENTAL IMPACTS ARISING FROM
ROAD TANKERS TRANSPORTING PETRO-CHEMICAL
SUBSTANCES**

**Dissertation submitted in fulfillment of the requirements for the degree
Master Environmental Management of the Potchefstroomse Universiteit vir
Christelike Hoër Onderwys**

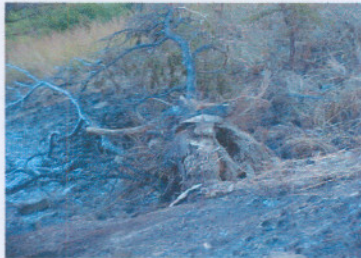
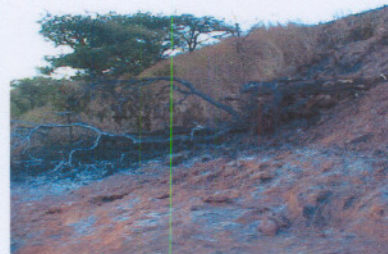
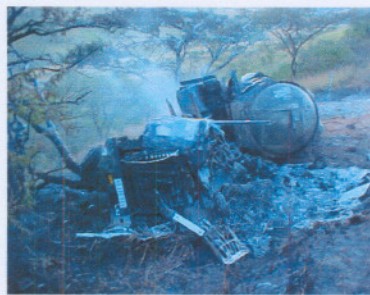
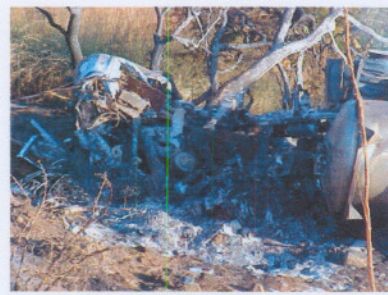
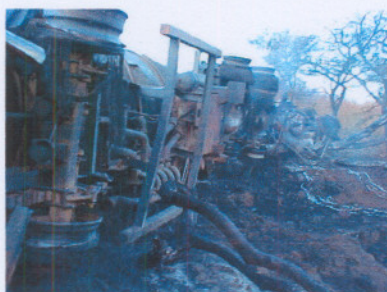
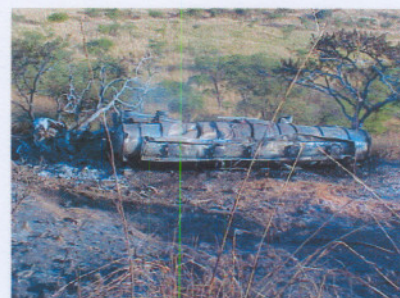
Figures 4, 5, 6, 7, 8 and 9 below is an example of an accident where a petro-chemical road tanker lost control and left the N3 national road just outside Warden in the Free State during 2001. The vehicle rolled and the tank shell then ruptured causing its product to escape and ignite resulting in much ground

contamination, ecological damage as well as air pollution. The damage to surrounding vegetation is evident in the figures however ground seepage of the spilled product also occurred but is not clearly visible.

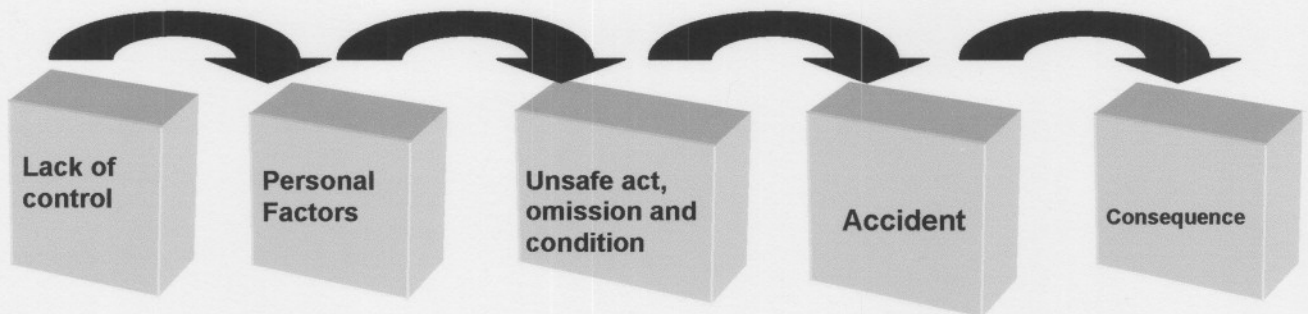
- Lack of control by management, permitting,
- basic causes (personal and job factors), that lead to,
- immediate causes (substandard practices/conditions/errors), which are the proximate causes of,
- the accident, which results in,
- the loss or consequence (minor, serious or catastrophic).

The factors are of a fixed and logical order. Each one is dependent on the one immediately preceding it, so that if one is absent, no consequence can occur. The theory can be visualized as five standing dominoes and the behavior of these dominoes is studied when they are subjected to a disturbing force.

When the first, lack of control, falls, the other four automatically follow, unless one of the factors has been corrected, i.e. removed, thereby creating a gap in the required sequence for producing an accident.

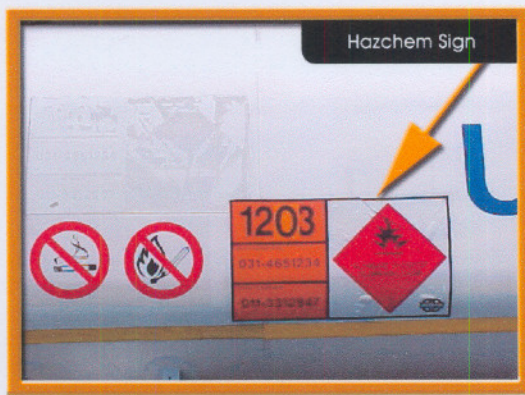
Figure 10 : Hazchem Sign

carrying dangerous products. Using a code, called the Hazchem Emergency Action Code, it provides information which the emergency services can quickly check and understand. It tells them how to deal with a spillage, leak or fire. The diamond tells the emergency services and the public what the primary hazard is,

The sign also includes a United Nations substance identification number, which informs the emergency services and others of the product contained in the vehicle. A telephone number is also provided, which the emergency services can call for expert information if they have a special problem. The Hazchem sign was originally a voluntary practice implemented by the Chemical Industries Association. However, as with so many other sections of the comprehensive safety system built up over the years by the industry and working together with the emergency services, it has become law. (Figure 10 below indicates the format of a typical Hazchem sign positioned on a tank),

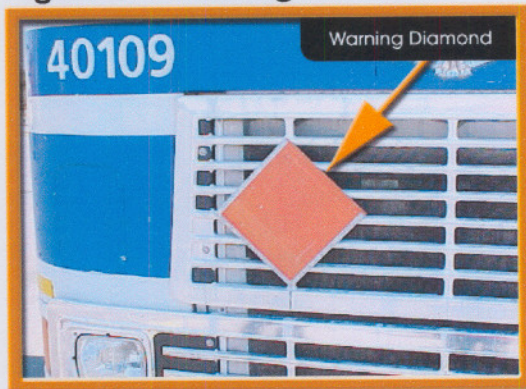
Figure 11: Warning diamond

- is the orange danger warning diamond available? (Figure 11 indicates the positioning of the orange warning diamond. This diamond is displayed on the front of vehicles that are used for the transporting of dangerous substances),

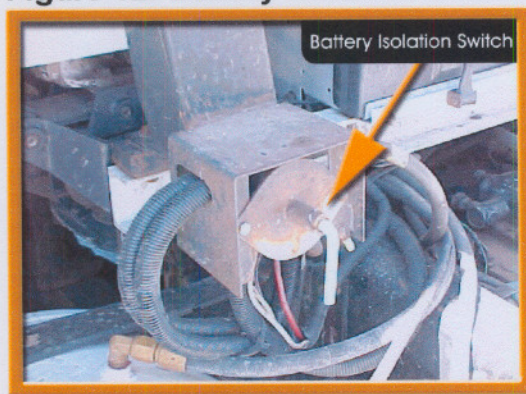
Figure 12: Battery Isolation Switch

- do the tyres comply with the regulatory requirements? (i.e. is the tread depth 5mm or more and are the tyres in a good condition?),
- are there cooking gas cylinders on the road tanker? (If gas cylinders for cooking purposes are present then these must be taken into safe custody by security while the vehicle is on our premises and returned when it leaves the site),
- is there a battery electrical isolation switch present? (Figure 12),

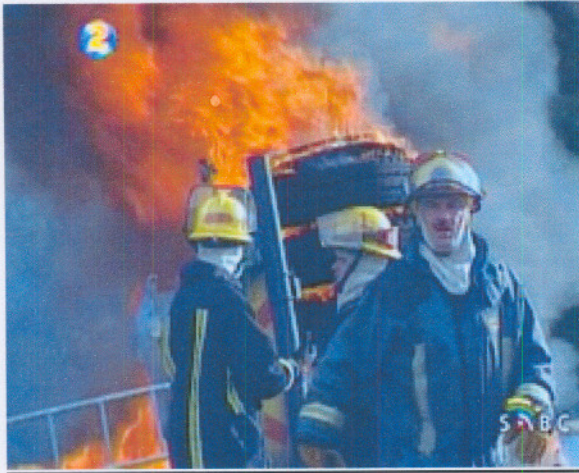
Annexure 2 – INTERNET ARTICLE OF A ROAD TANKER ACCIDENT

Damaged City Road Partially Closed. (Main Johannesburg routes still closed after tanker fire) – T. Thale.
