# Flooding, flood risks and coping strategies in urban informal residential areas: The case of Keko Machungwa, Dar es Salaam, Tanzania

This article presents findings from a study carried out in Keko Machungwa informal settlement in Dar es Salaam under the auspices of the Disaster Management Training Centre of Ardhi University, Tanzania. The settlement has experienced frequent flooding in the past five years, and this study explores the causes, risks, extent of flooding and coping strategies of residents as well as municipality and city officials. Key methods employed in capturing empirical evidence included mapping of zones by severity of flooding, interviews with households, sub-ward leaders, and municipal and city officials. Non-participant observation, primarily taking photographs, complemented these methods. Laboratory tests of water samples taken from shallow wells in the settlement were performed to establish the level of pollution. In addition, records of prevalence of water-borne diseases were gathered from a dispensary within the settlement to corroborate flooding events, water pollution and occurrence of such diseases. Findings show that flooding is contributed to by the

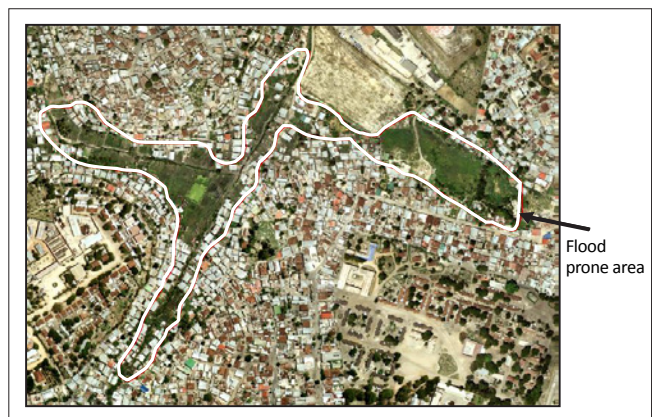
FIGURE 1: Aerial photo showing flood-prone areas.

Although about 75% of the settlement does not experience flooding, the rest of the area can be subdivided into (1) most severely flooded and (2) moderately flooded areas. The most seriously affected area of the settlement is that between one and two metres above mean sea level. A topographic analysis of the settlement showed that this area covered 5.07 hectares,

which constituted 16.37% of the total study area (see Figure 1). There were 76 houses in this area. During the peak hours of flooding water reaches a height of half to one metre above the ground floor. During the rainy season the area gets filled up with water from within and outside Keko Machungwa. The water seriously affects houses built along the valley. The area that was moderately flooded covers 2.84 hectares and lies between two and four metres above mean sea level. There were 130 houses in this area.

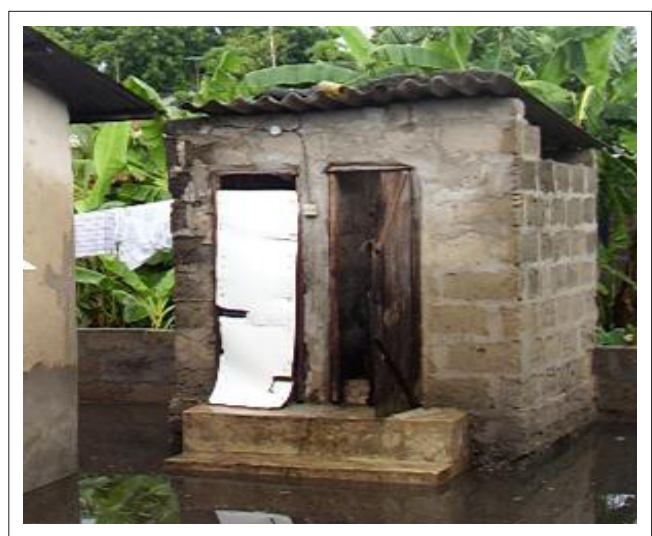
FIGURE 2: A pit latrine surrounded by stagnant water during rainfall season.

Household interviews conducted in the settlement have shown that 90% of the houses use pit latrines for sanitation. The combination of a high water table and the use of pit latrines results in frequent filling up of the pits when it rains heavily (see Figure 2).

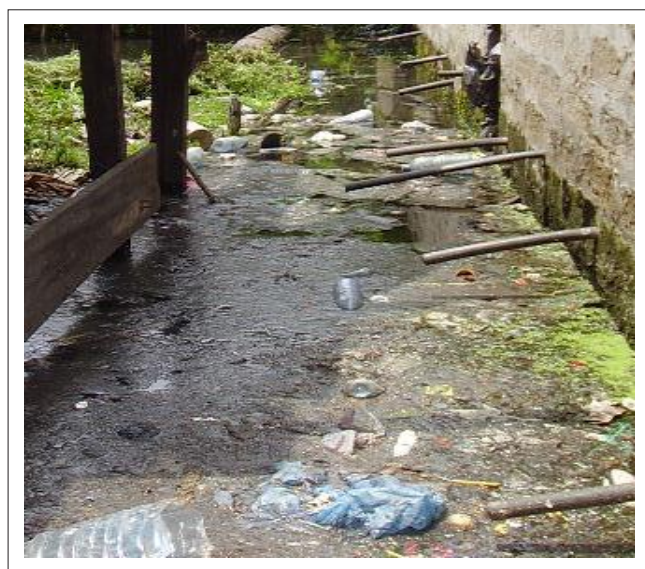
**FIGURE 9:** Outlet pipes.

Water outlet pipes were built above the plinth level to drain off water. The most common pipes were of 20 mm – 50 mm in diameter. These outlets reduced water to a certain extent, because during heavy rainfalls water entered houses through doors and other wall openings (see Figure 9). Only one household out of 30 used this particular strategy.
