# **Analysis of steel wire rope mesh as roof support in underground mines**

Dissertation accepted in fulfilment of the requirements for the  
degree *Master of Engineering in Mechanical Engineering* at  
the North-West University

**Keywords:** Steel wire rope mesh, impact analysis, underground mining roof support

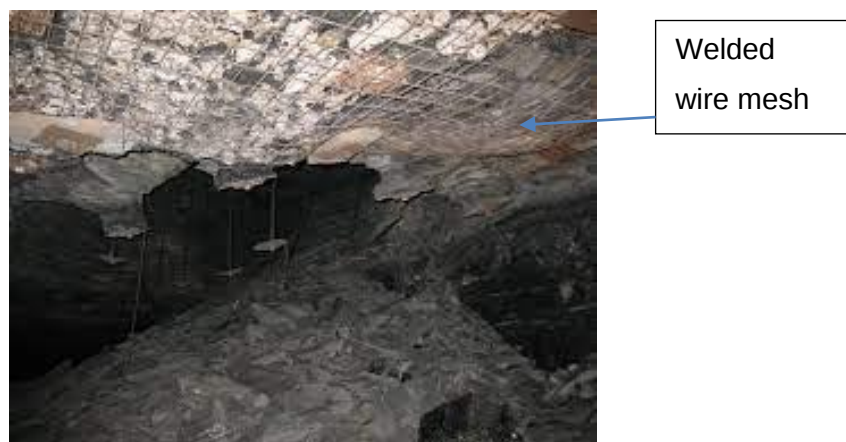
**Figure 1: Welded wire mesh installed underground**

Screen material in the form of welded or galvanized chain link steel wire mesh reinforced with steel wire ropes are mostly used for underground roof support (Figure 1). Galvanized chain link mesh is formed by bending individual wires to form diamond shaped apertures (Figure 2 (a)). Welded mesh is made by welding individual wires to form a wire mesh screen as shown in Figure 2 (b). Wire mesh screens are installed to protect people and equipment from small pieces of rocks falling in between rock bolts. These screens thus form a critical part of underground mine roof support. Welded and galvanized chain link steel wire mesh designs have proven to be quite cost-effective whilst still meeting the necessary kinetic energy requirements. However, according to the Harmony Gold standard operating procedure for temporary and permanent netting installation (Harmony Gold, 2020), they require an overlap of two apertures between mesh screens to provide sufficient support. This equates to a maximum of 300 mm overlap, contributing to total material cost. Harmony Gold is one of South Africa's largest gold mines and operates nine underground mines in the country (Harmony Gold, 2023).

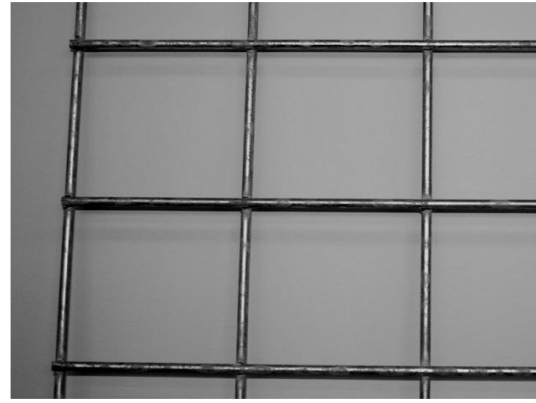
**Figure 2: (a) Chain link and (b) welded wire mesh typically used in underground mine roof support (Player *et al.*, 2008)**

The galvanized wire mesh screen was made of 4 mm diameter steel wires woven together in a zigzag pattern to form a diamond-shaped grid (Player *et al.*, 2008). The woven steel wires form a chain link, which ensures the diamond-shaped grid is of a fixed shape (Figure 2(a)). The welded wire mesh screen comprised 5.6 mm steel wires that were welded together to form a square grid pattern (Figure 2(b)). Tag welds ensure the square grid is of a fixed shape. The chain link and welded wire mesh screens were installed on a rigid frame and restrained along each of its sides instead of only at four corners; this setup is called rigid boundary conditions. Boundary conditions are the corners where the wire meshes are fixed when installed (Player *et al.*, 2008).

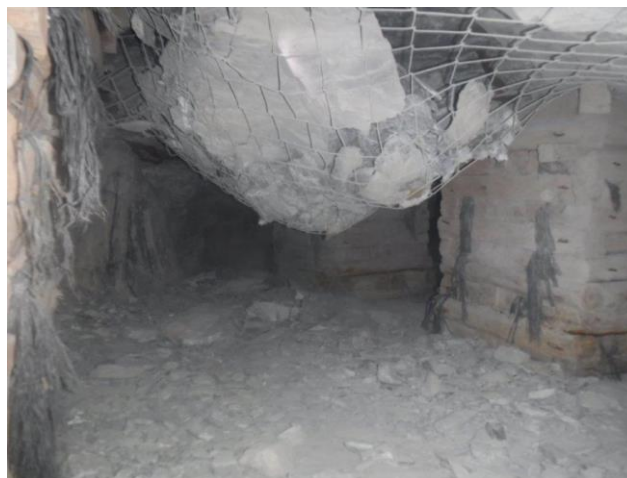
**Figure 3: Chain link wire mesh deflection after fall of ground**

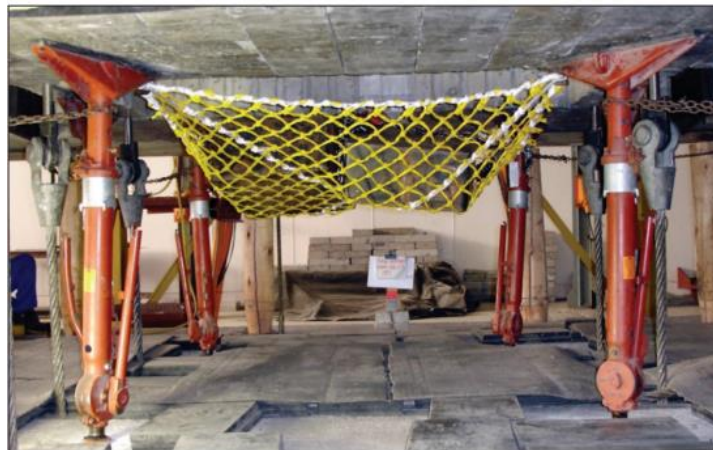
Figure 10: Polymer mesh after drop test (Skarbøvig *et al.*, 2011)

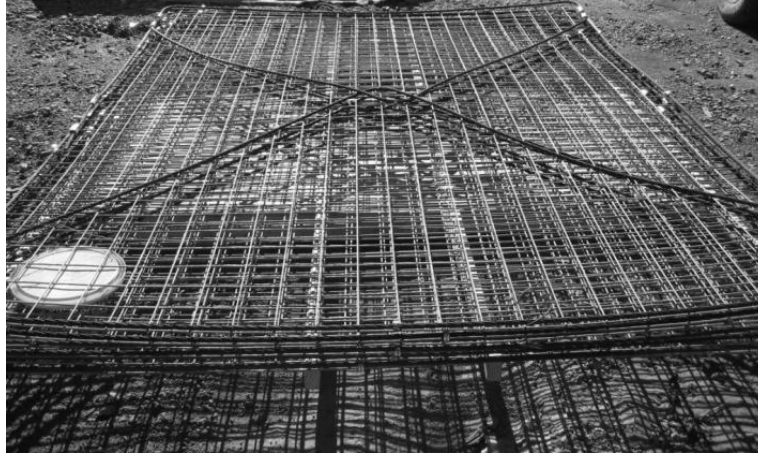
**Figure 11: Welded mesh reinforced with wire rope (Potvin and Heal, 2010)**

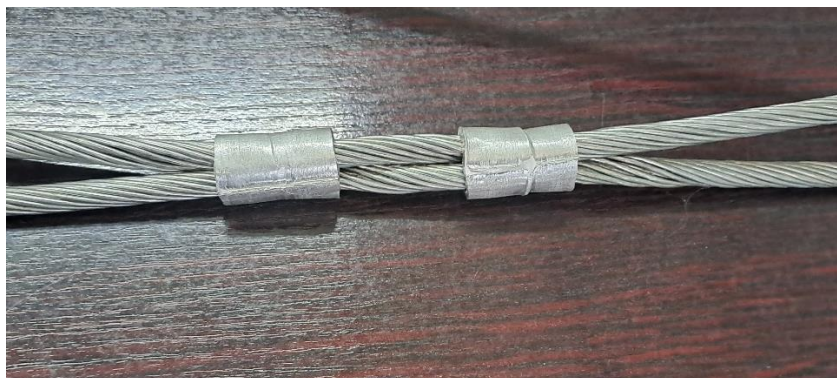
**Figure 12: Ferrules used to connect two endpoints of wire ropes**

The energy absorption capability of welded mesh reinforced with wire rope can be further increased by controlling the torque applied to nuts of Crosby clamps. Ferrules or Crosby clamps are used to connect two endpoints of wire ropes (Figure 12). Controlling the torque applied to the nuts of the Crosby clamps allows for more deflection of the wire rope, which prevents it from fracturing (Ortlepp & Stacey, 1997). A similar approach of using friction clamps to allow wire ropes to slide at a certain load was followed by Duffy (1992). Ferrules are used to connect the endpoints of MSP's wire ropes because they are more cost effective and more practical to use during manufacturing.

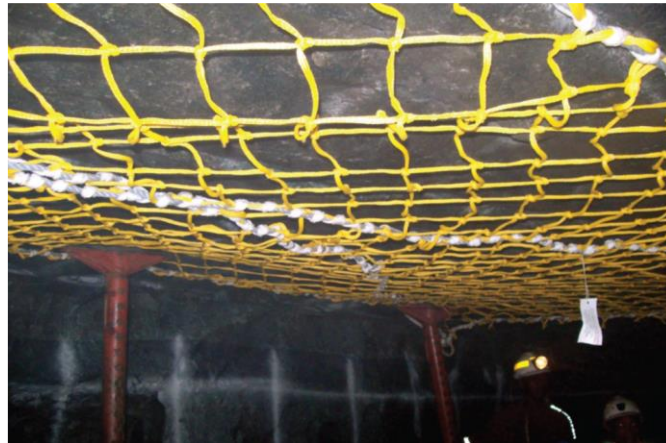
**Figure 13: Mechanical jacks used to clamp braided mesh to the hanging wall (Skarbøvig *et al.*, 2011)**

is the mine roof above where the ore is present. Clamping the mesh to the hanging wall with mechanical jacks was found to be the most common and easiest way of surface fixture (Figure 13). These surface fixtures were found to be acceptable as long as they did not damage the mesh. Depending on the mine practice and standards, plates attached to rockbolts are also widely used as surface fixtures (Whiting, 2017).

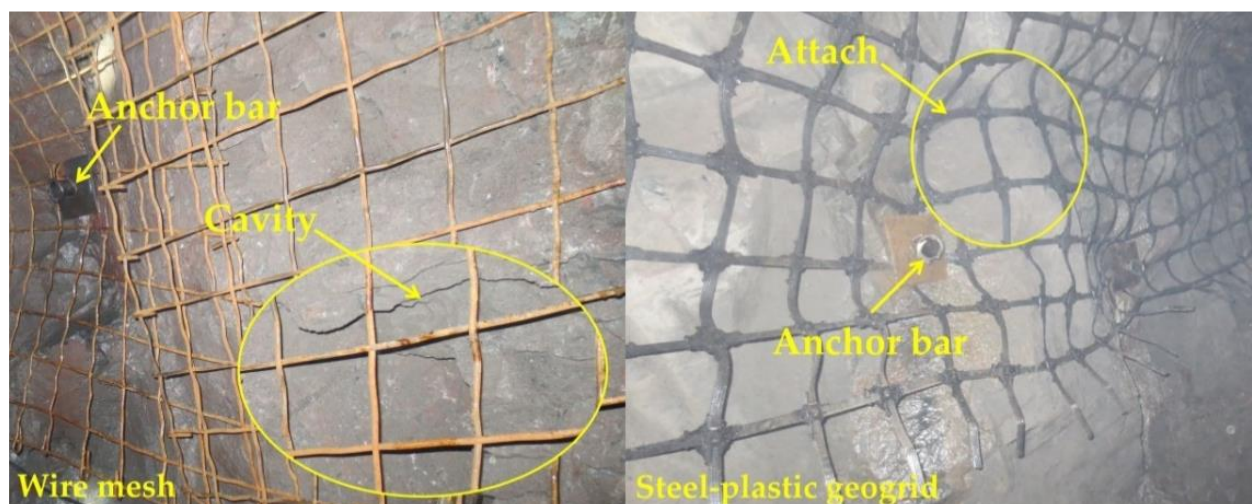
**Figure 16: Welded wire mesh vs geogrid mesh underground installation (Wang *et al.*, 2022)**

Welded wire mesh and geogrid mesh were also compared in underground tests (Wang *et al.*, 2022). The geogrid mesh was easier to install thus reducing the labour costs. Due to the irregular shape of the rock face, the deformation capacity of the geogrid mesh is an advantage as it fits better to the surrounding rock (Figure 16). Corrosion of the welded mesh was also observed while the geogrid was corrosion free. However, the exposure period for both meshes was not specified in the study.

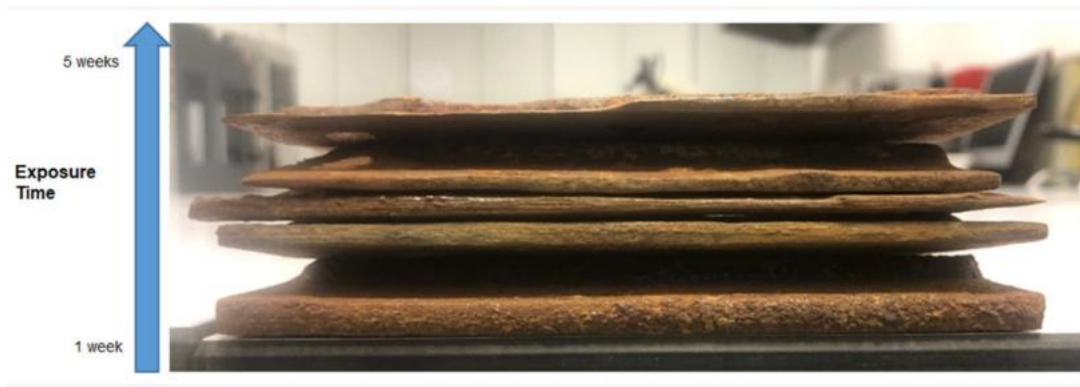
Figure 23: Thickness loss of carbon steel test specimens (Fortes *et al.*, 2022)

Thirty carbon steel metal plates with dimensions 50 x 60 x 6 mm were kept in water contaminated with acid mine drainage (Fortes *et al.*, 2022). The tests were conducted for thirty weeks, and one plate was taken from the water solution every week. Each metal plate was then dried, and its weight measured to determine the mass loss. It was found that the water solution greatly affected the weight and thickness of the metal plates with decrease in mass and thickness each week (Figure 23). After 30 weeks the metal plates basically disappeared. Thus, it is evident that metal immersed in groundwater and contaminated by acid mine drainage experiences substantial loss in cross sectional area, consequently affecting its strength.

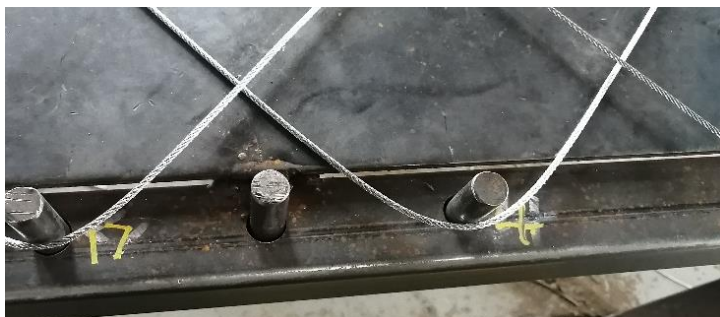
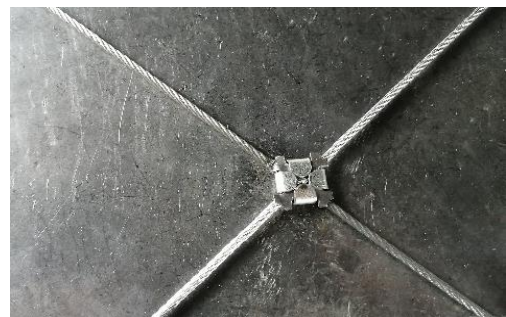
**Figure 27 : Wire rope mesh weaved in a fixed configuration and (b) clevis clips hammered flat**

Wire meshes were manufactured at MSP's factory, in Vereeniging South Africa. Meshes were manufactured on a production table as per MSP general work instructions. As can be seen in Figure 27 (a), the galvanized steel wire ropes were weaved in a fixed configuration. The cable ends were tensioned by hand and connected with aluminium ferrules. Ferrules are used to connect two endpoints of wire ropes. Clevis clips were bent and hammered flat at each wire rope intersection (Figure 27 (b)). After manufacture, the wire mesh was dipped in bitumen for an extra layer of corrosion protection.

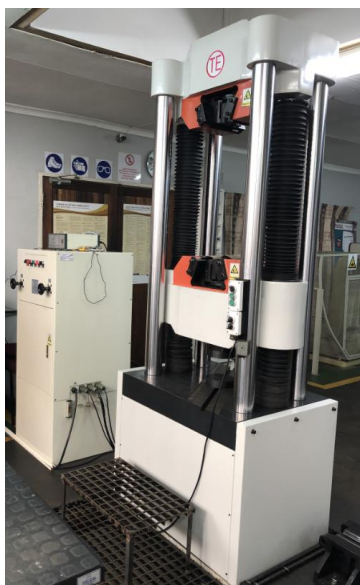
Figure 28: Sans universal tensile testing machine used in the tensile tests

Tensile tests were done at Vaal Metallurgical Laboratory as per tensile testing of metallic materials standard ISO 6892-1 (ISO, 2019). Tensile tests of corroded 3 mm (1 x 19) galvanized steel wire ropes were also done at Vaal Metallurgical Laboratory to determine the loss of tensile strength due to corrosion. Samples of 150 – 200 mm in length were clamped on each side and tensile tested using a 300 kN Sans universal tensile testing machine (Figure 28) until fracture. As per standard ISO 6892-1, the strain rate was kept between 0.00025 and 0.0025 s<sup>-1</sup>.

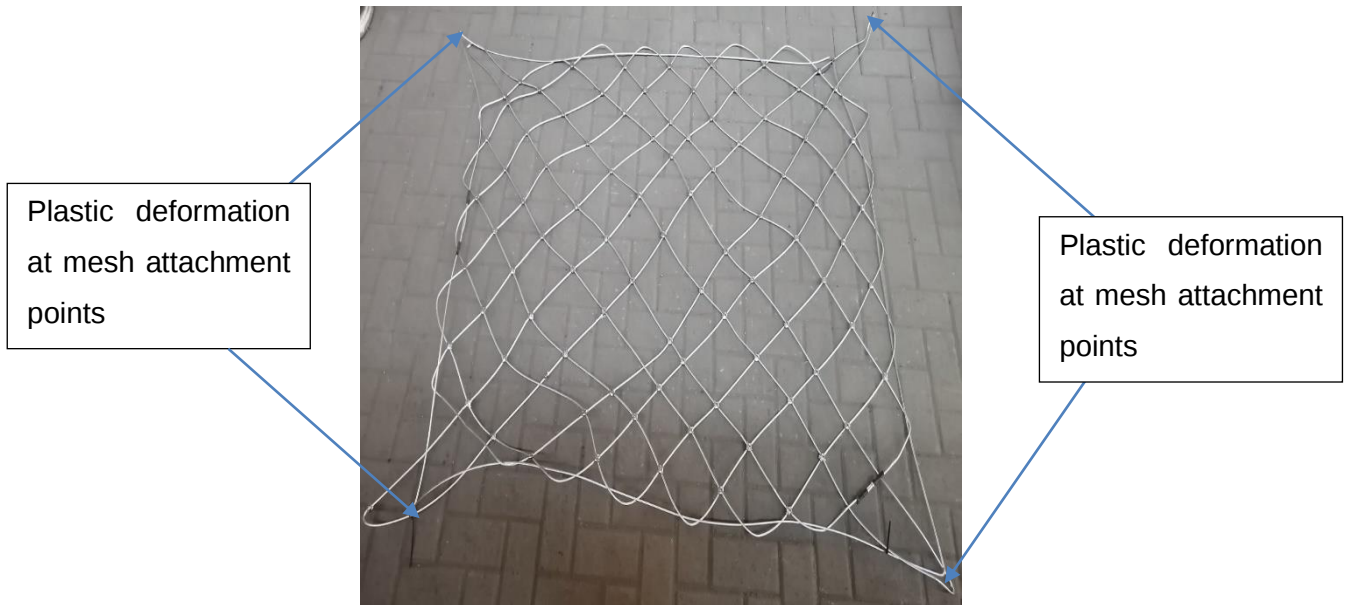
**Figure 39: 4 mm (1x19) inner and outer wire rope mesh condition after a 300 mm drop test**

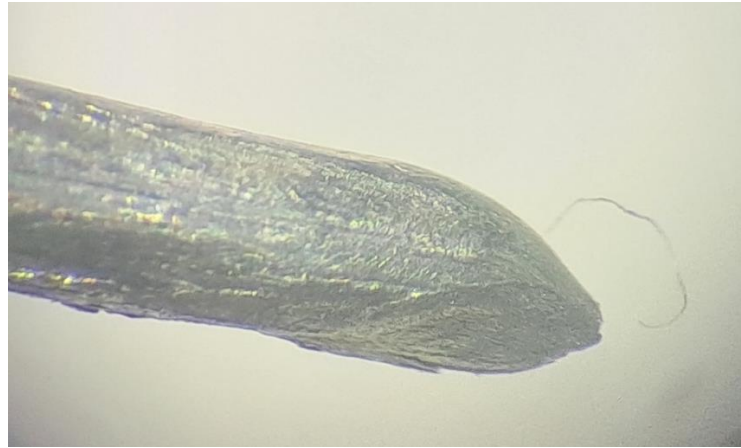
**Figure 41: Wire rope ductile fracture**

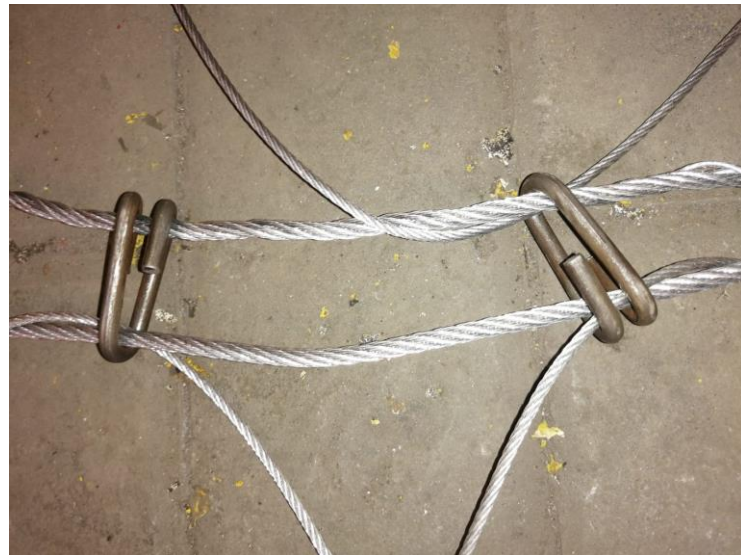
No visible plastic deformation of the Rocnet connectors was observed after a drop test from 100 mm on the wire mesh modular system, as illustrated in Figure 42.

**Figure 42: Rocnet connectors after drop test**

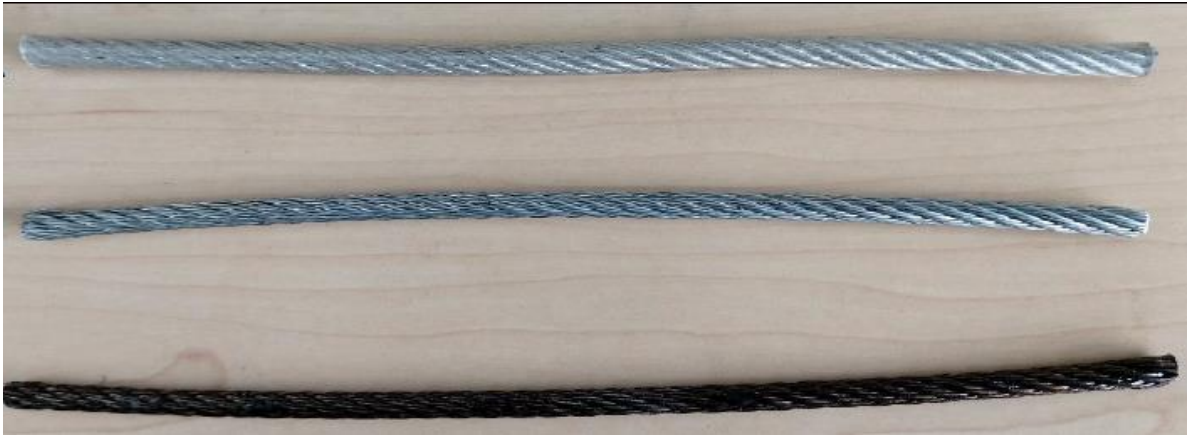
**Figure 48: Galvanized PVC coated wire rope (top), galvanized wire rope (middle) and galvanized wire rope coated with bitumen (bottom) from MSP's wire mesh before salt spray test**

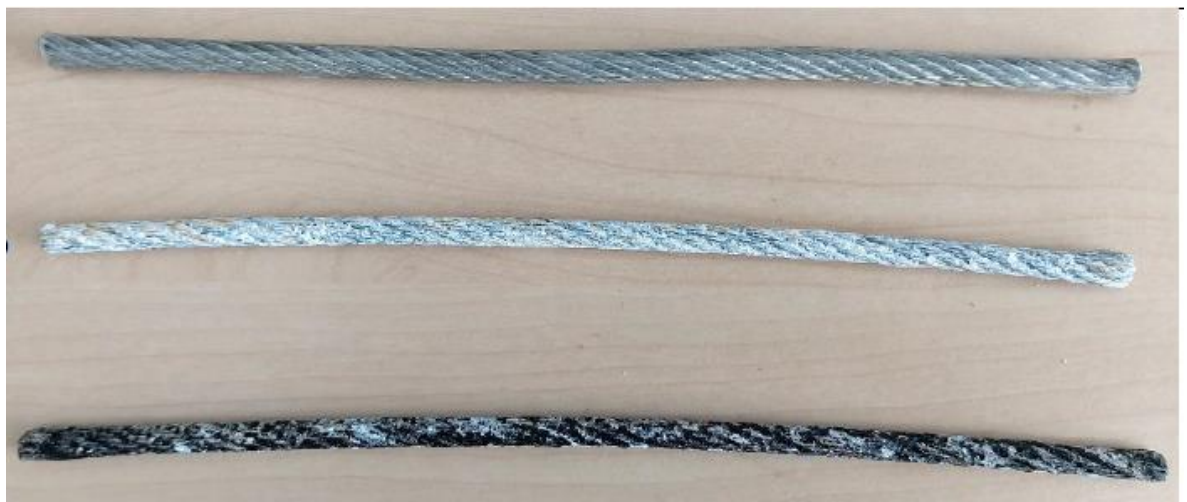
**Figure 49: Galvanized PVC coated wire rope (top), galvanized wire rope (middle) and galvanized wire rope coated with bitumen (bottom) from MSP's wire mesh after salt spray test**
