# **Classification of water resources within Quaternary Catchment C22K**

Mini-dissertation accepted in partial fulfilment of the  
requirements for the degree *Master of Environmental  
Management* at the North-West University

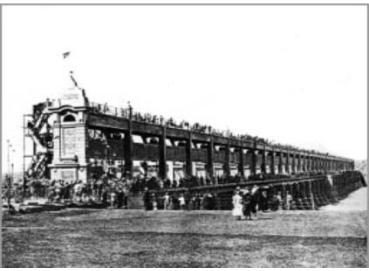
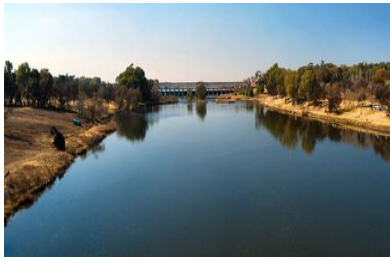
The Vaal Barrage falls under the Emfuleni Local Municipality (ELM), in the Sedibeng District, Gauteng Province, South Africa. The different phases of the construction of the Barrage are summarised as (Figure 2):

- A. Morphology structure of Barrage in the Vaal River at time of inauguration in 1923 (Tempelhoff *et al.*, 2007).
- B. Vaal Barrage Construction phase. The width of the Vaal River varied according to the season and as a result it was more difficult to cross the river during the rainy summer season. During the summer the width was wider, and depth deeper than winter periods. When the Vaal River Barrage was built in 1923 the width of the river expanded. Infiltration of water also increased due to the wider river (Meyer & Strauss, 2014).
- C. After Construction Phase. Current form of Barrage in the Vaal River.

| A – Bottom of Reservoir | B – Construction Phase | C – After Construction Phase |

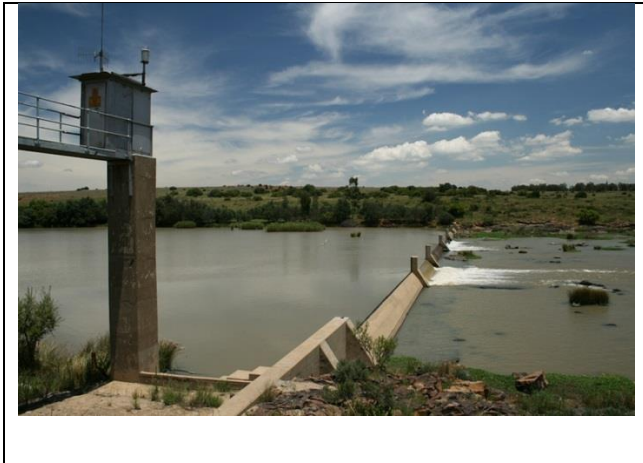
**Figure 11: Vaal Dam**

There are two dam gauges namely the Vaal Dam (Figure 11), upstream of the study area and, the Vaal Barrage which falls within the study area. These dams were the forerunners of the great barrages and dams, which today control the river on which the gold fields of the Witwatersrand and the surrounding industrial complex depend so heavily. Information regarding their status was attached in Table 5.
