Sustainable drinking water supply service and development in the face of different resource challenges. A case study of Midvaal Water Company, South Africa

Thesis submitted in fulfilment of the requirements for the degree
Doctor of Philosophy in Environmental Sciences at the North-
West University

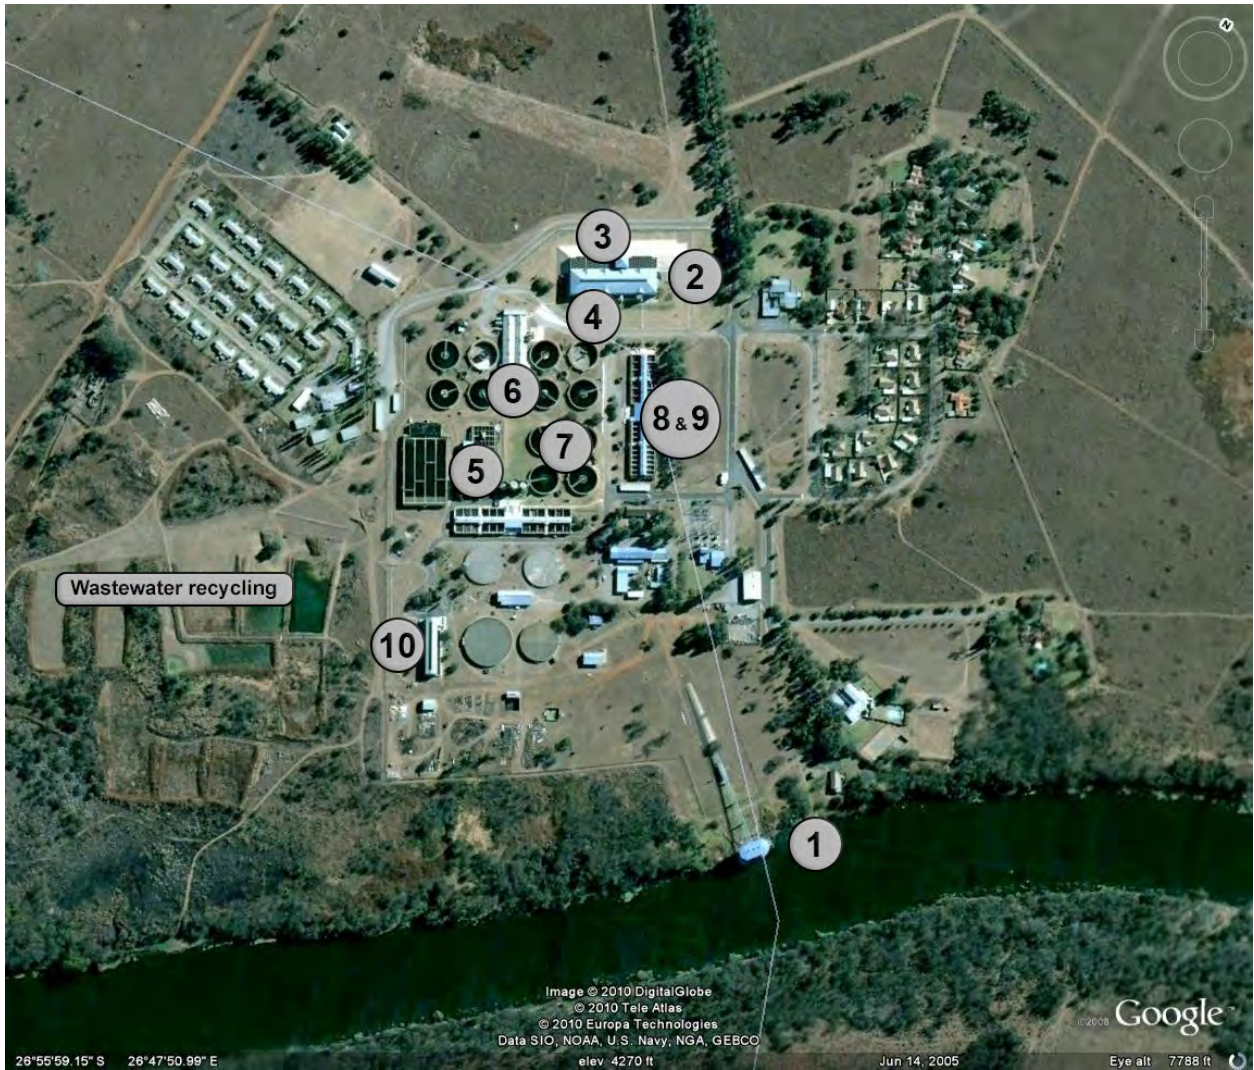
Figure 2-2: An aerial view of Midvaal Water Company (2010). The water treatment plant abstracts on average 130 ML/day, has a design capacity to treat 320 ML/day and a supply area that extends over more than a 1 000 km²

- (7) Sedimentation in 12 circular clariflocculators and one horizontal flow sedimentation dam
- (8) Filtration in rapid gravity sand filters
- (9) Disinfection by means of chlorine gas
- (10) Pump station for distribution of the final water to 11 reservoirs in the Klerksdorp, Orkney, Stilfontein and Hartbeesfontein (KOSH) area as well as Vierfontein

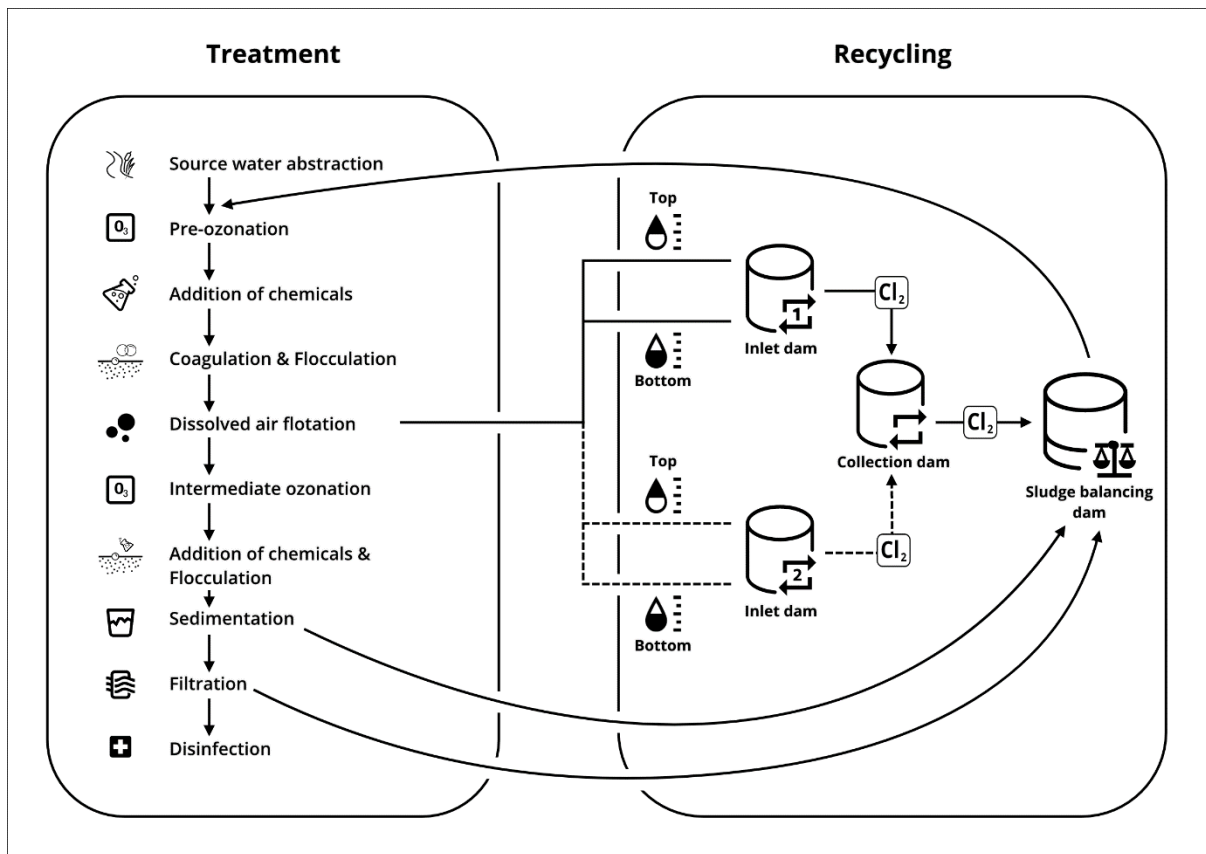
Figure 2-3: Sequence of the various treatment processes at the Midvaal Water Company and the flow of the wastewater recycling system

Midvaal Water Company recycled wastewater, produced at three drinking water treatment processes (dissolved air flotation, sedimentation and filtration), parallel with treatment (Figure 2-3).

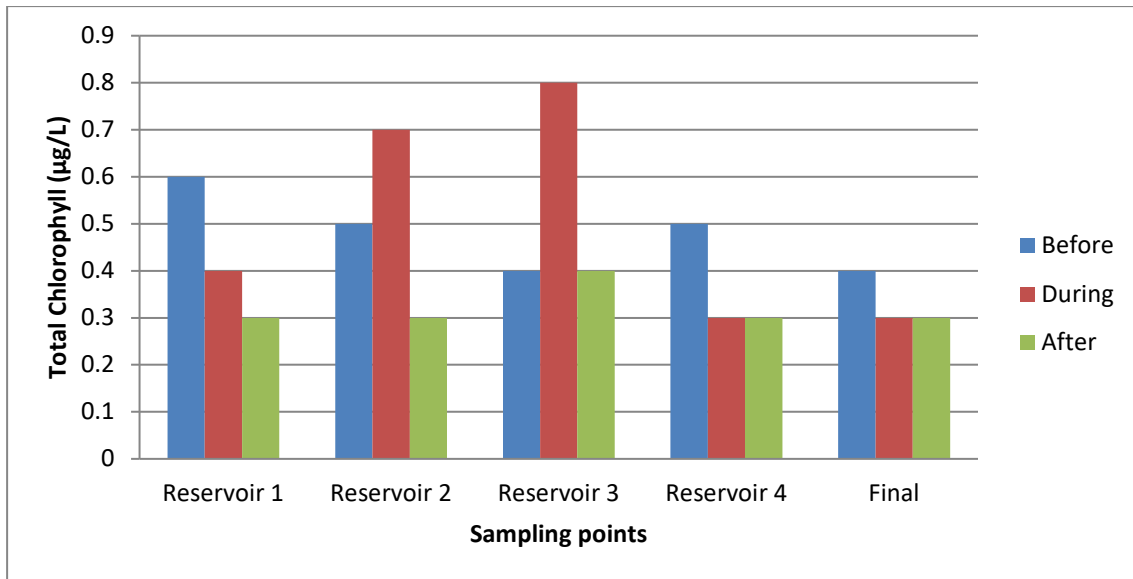
Figure 3-4: The average total chlorophyll concentrations three months before, during and three months after the DAF shutdown for four Midvaal Water Company reservoirs, and for the final water

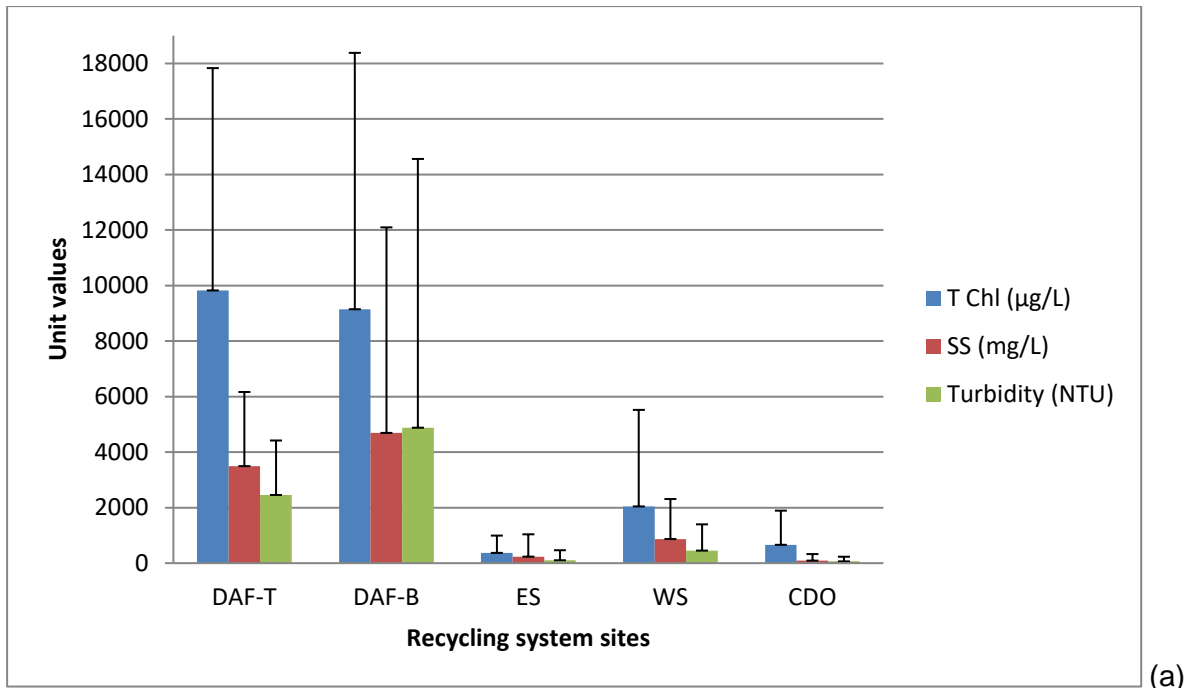
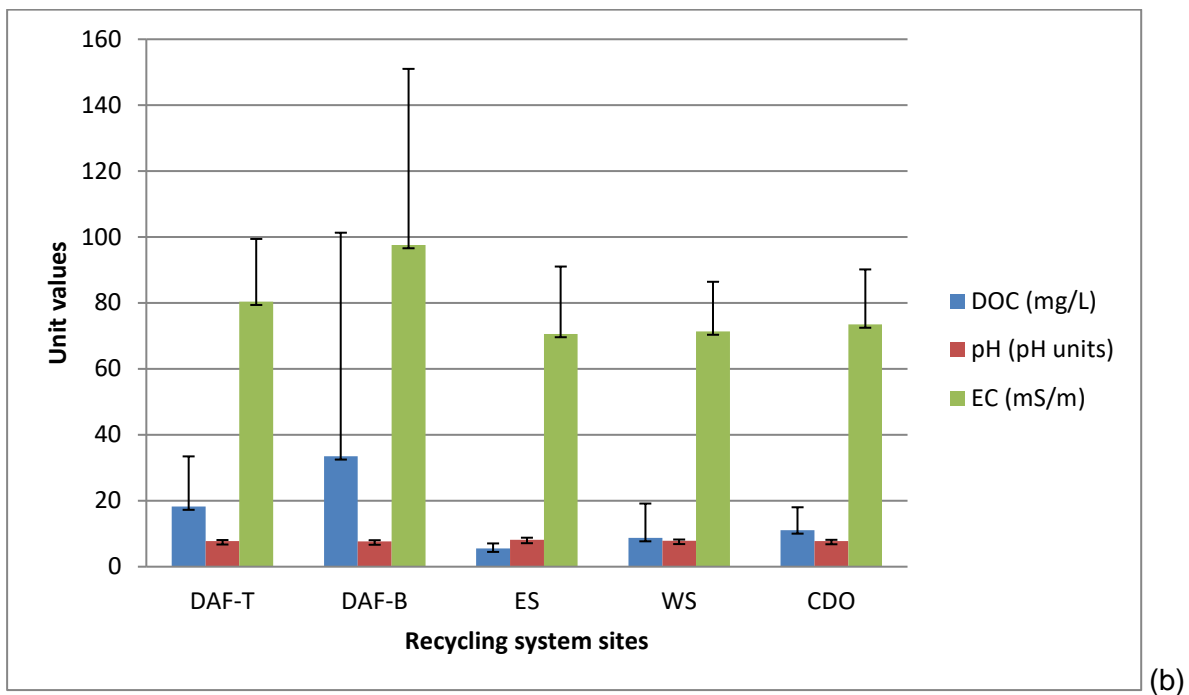
Figure 4-1: (a and b) Mean total chlorophyll (T Chl), suspended solids (SS), turbidity (NTU), dissolved organic carbon (DOC), pH and electrical conductivity (EC) concentrations with standard deviation error bars of the wastewater sampled at various sites for the water recycling system from 5 June 2013 to 3 February 2016

The mean total chlorophyll, suspended solids, turbidity, dissolved organic carbon, pH and electrical conductivity for each section of the wastewater recycling system are compared in Figure 4-1. The wastewater from the DAF top had means of 9 825 µg/L total chlorophyll, 3 497 mg/L suspended solids, 2 457 NTU turbidity and 18 mg/L dissolved organic carbon, whereas the DAF bottom had means of 9 148 µg/L total chlorophyll, 4 693 mg/L suspended solids, 4 880 NTU turbidity and 33 mg/L dissolved organic carbon. The quality of the wastewater (sludge from DAF units) that overflowed from the collection dam to the sludge balancing dam improved significantly with means of 662 µg/L total chlorophyll, 93 mg/L suspended solids, 65 NTU turbidity and 11 mg/L dissolved organic carbon. The total chlorophyll, suspended solids and turbidity of the west wastewater were noticeably higher than those of the east wastewater. The pH and electrical conductivity for each section's wastewater varied very little over the study period.

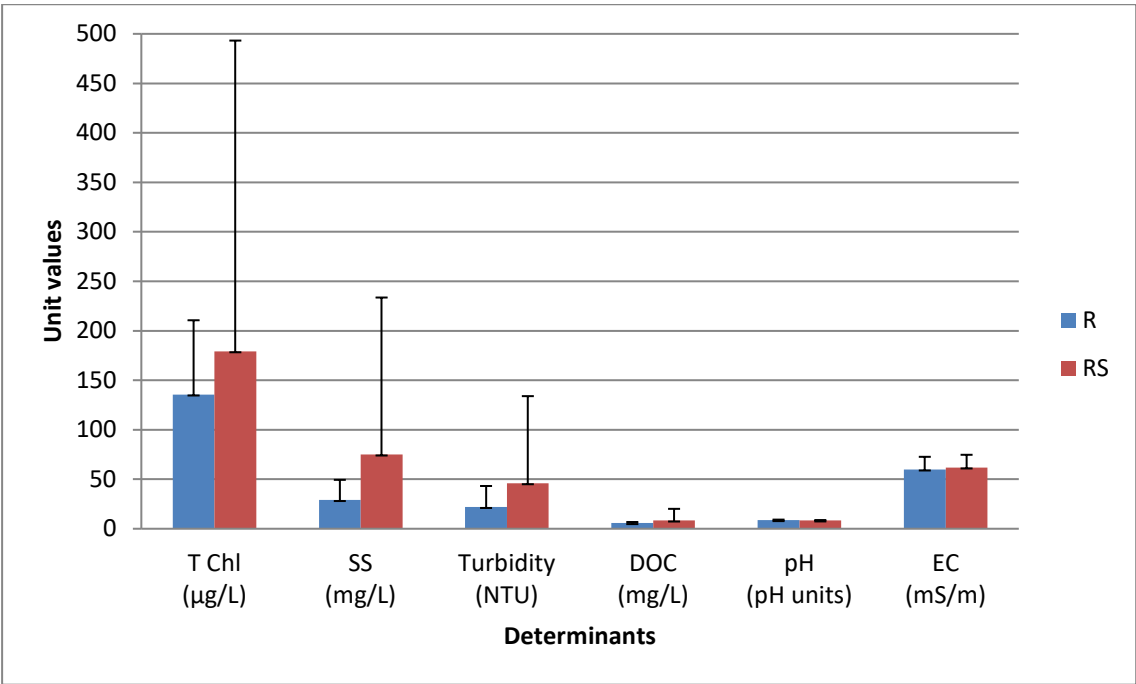
Figure 4-2: Mean total chlorophyll (T Chl), suspended solids (SS), turbidity (NTU), dissolved organic carbon (DOC), pH and electrical conductivity (EC) concentrations with standard deviation error bars for the Middle Vaal River (R) and recycle stream (RS) from 5 June 2013 to 3 February 2016

Figure 4-2 illustrates the water quality of the recycle stream compared to the water quality of the Middle Vaal River. The mean pH and electrical conductivity of the recycle stream and river differed significantly according to Kruskal-Wallis (see Annexure C, Table C.1) although these differences are small (8.4 vs. 8.7 pH and 62 vs. 60 mS/m electrical conductivity for recycle stream and river respectively). The mean values of total chlorophyll (179 vs. 136 µg/L), suspended solids (75 vs. 29 mg/L), turbidity (46 vs. 22 NTU) and dissolved organic carbon (8.3 vs. 5.7 mg/L) of the recycle stream were higher than that of the river water but only suspended solids and turbidity differed significantly according to Kruskal-Wallis with *p*-values < 0.05 (see Annexure C, Table C.1). The total chlorophyll concentration in the recycle stream ranged from 11 to 6 451 µg/L. The water quality of the recycle stream that originated from the sludge balancing dam represents an improvement compared to that from the collection dam overflow in terms of total chlorophyll (179 vs. 662 µg/L), suspended solids (75 vs. 93 mg/L), turbidity (46 vs. 65 NTU) and dissolved organic carbon (8.3 vs. 11 mg/L). This observed improvement can be ascribed to a dilution effect when water from the collection dam overflow was combined with higher-quality water from the east and west wastewater already present in the sludge balancing dam.

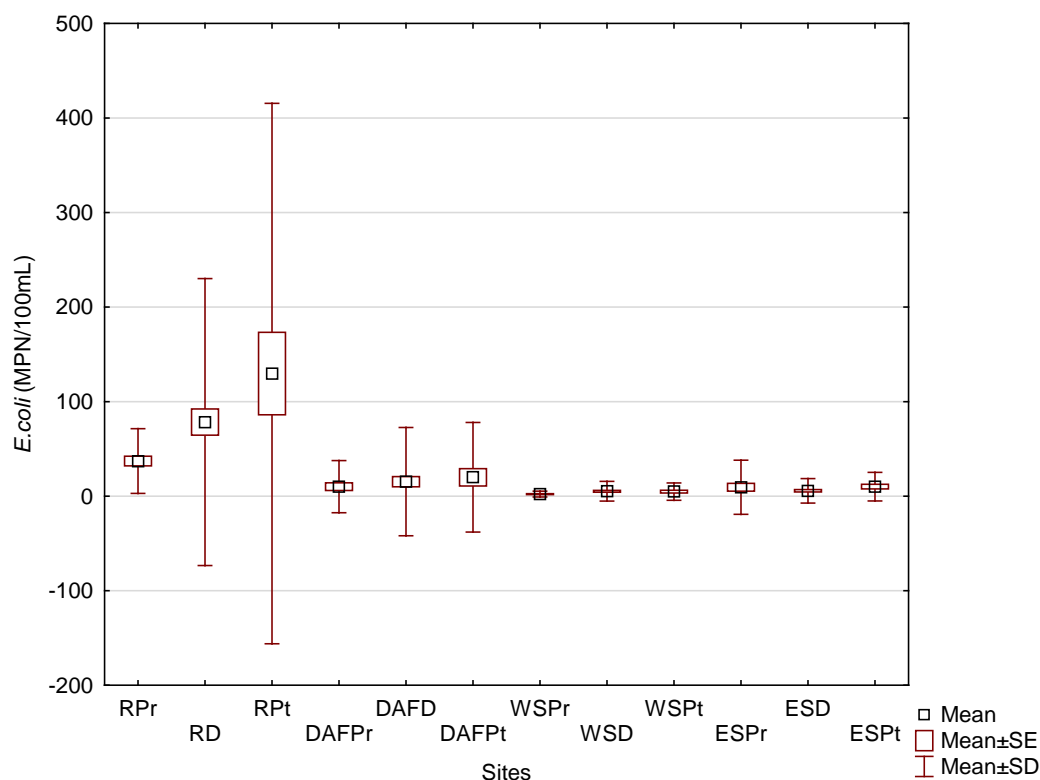
Figure 4-7: *E. coli* concentrations of the Middle Vaal River, after dissolved air flotation (DAF), after west and east sedimentation for the periods prior to, during and after implementation of wastewater recycling; RPr, RD and RPt: river pre, during and post recycling system; DAFFPr, DAFD and DAFPt: DAF pre, during and post recycling system; WSPr, WSD and WSPt: west sedimentation pre, during and post recycle system; ESPr, ESD and ESPT: east sedimentation pre, during and post recycling system

Mean *E. coli* concentrations continuously increased over time in the river and after DAF but remained at ≤ 10 MPN/100 mL after the west and east sedimentation processes (Figure 4-7).

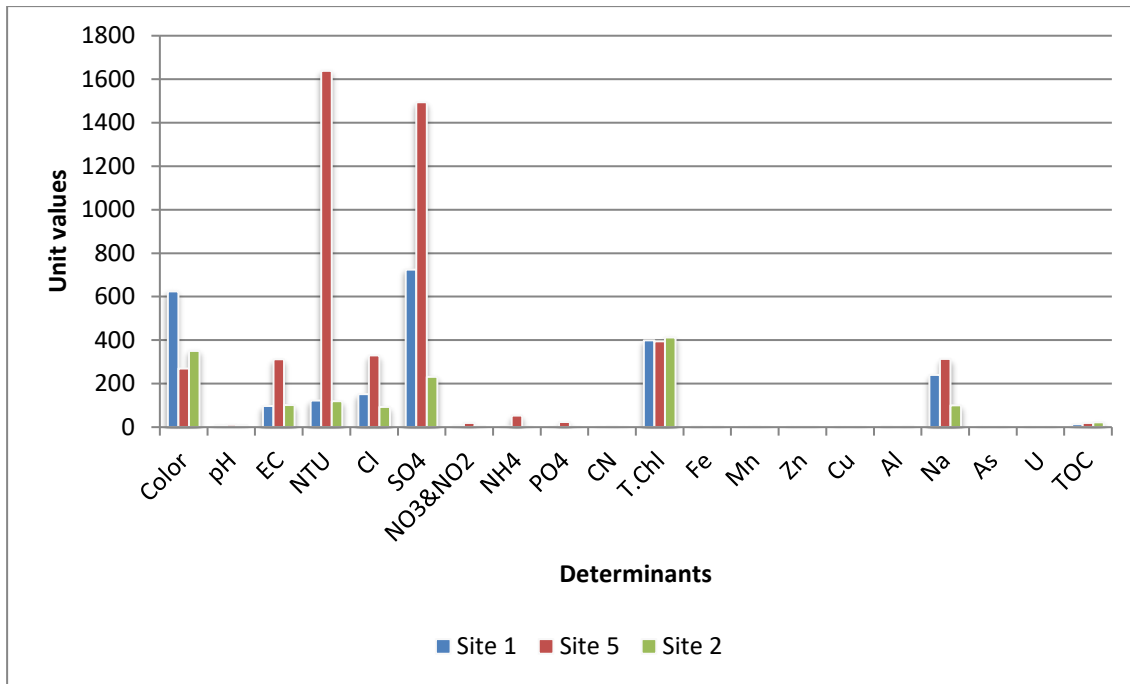
Figure 5-4: Maximum values derived from the water quality monitoring data for sites 1, 5, and 2 from October 2002 to December 2015; Site 1: Middle Vaal River above the confluence of the Koekemoerspruit; Site 5: Koekemoerspruit before the confluence with the Middle Vaal River; Site 2: Middle Vaal River below the confluence of the Koekemoerspruit; electrical conductivity (EC); turbidity (NTU); total chlorophyll (T Chl); total organic carbon (TOC)

Chloride, sulfate, total chlorophyll and sodium showed large variances in their concentrations from 2002 to 2015 at sites 1 and 2 in the Middle Vaal River and at sites 4 and 5 in the Koekemoerspruit. The maximum concentrations shown in Figure 5-4 for sites 1 and 5 indicate that their respective turbidity, chloride, sulfate, total chlorophyll and sodium concentrations could jointly have contributed to the maximum levels observed at site 2 and would therefore have been able to increase average measured levels of these determinants at site 2.

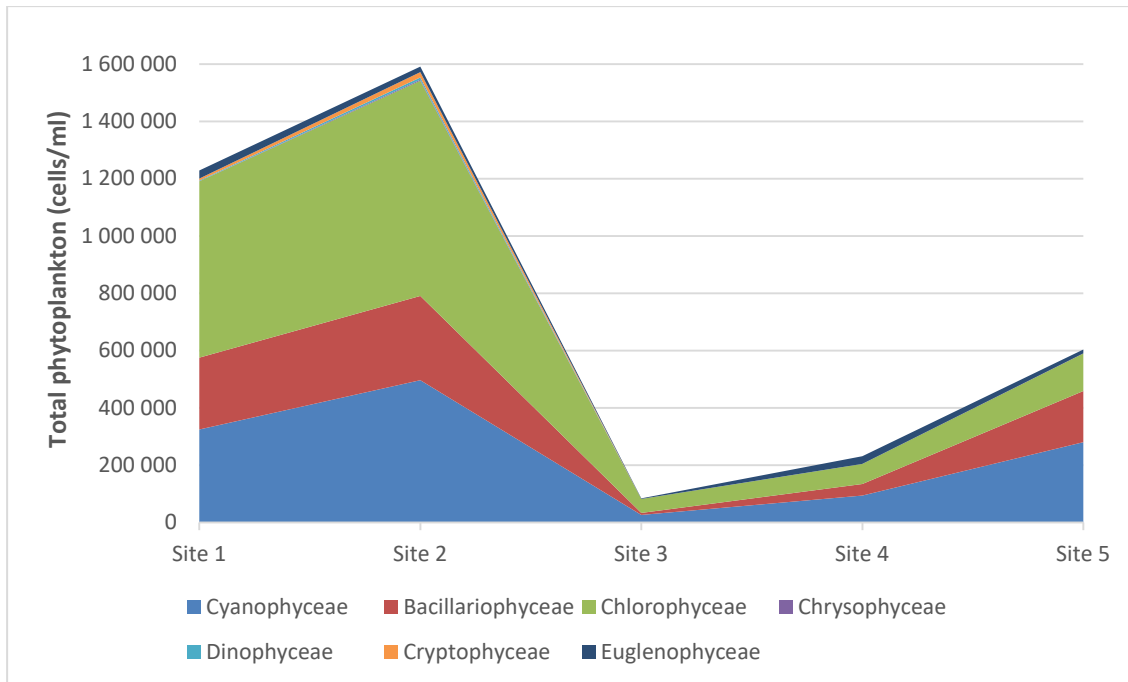
Figure 6-1: The total phytoplankton cells enumerated and grouped into seven taxa (classes) from November 2012 to October 2014 for site 1 (Vermaasdrift Bridge), site 2 (Middle Vaal River), site 3 (Enviroclear overflow), site 4 (Koekemoerspruit before Enviroclear overflow) and site 5 (Koekemoerspruit after Enviroclear overflow)

The total phytoplankton cells that were enumerated during the study period from November 2012 to October 2014 in the Middle Vaal River increased from 1 228 827 cells/ml at site 1 to 1 591 311 cells/ml at site 2 and might be ascribed to the influx of nutrients and algae from the Koekemoerspruit. The total cells of the Cyanophyceaea, Bacillariophyceae, Chlorophyceae, Chrysophyceae, Dinophyceae and Cryptophyceae each increased from site 1 to site 2 (Figure 6-1). Site 3 had the lowest total phytoplankton concentration of 84 747 cells/ml (5% of the cells at site 2). The total phytoplankton cells in the Koekemoerspruit also increased from 231 779 cells/ml at site 4 to 604 084 cells/ml at site 5 and these included cells of the Cyanophyceaea, Bacillariophyceae, Chlorophyceae, Chrysophyceae and Cryptophyceae (Dinophyceaea decreased). The cells of the Euglenophyceae decreased from site 1 (28 256 cells/ml) to site 2 (19 255 cells/ml) and from site 4 (26 815 cells/ml) to site 5 (13 541 cells/ml). The Kruskal-Wallis ANOVA indicated no significant difference between the Cyanophyceae, Chrysophyceae, Dinophyceae and Cryptophyceae for all the sites and this is important as algae may indicate certain pollution (see Annexure D, Table D). The total cell concentration for the Cyanophyceae, Chrysophyceae, Dinophyceae and Cryptophyceae ranged from 26 914 cells/ml (site 3) to 497 042 (site 2), 35 cells/ml (site 3) to 3 575 cells/ml (site 2), 42 cells/ml (site 5) to 7 715 cells/ml (site 2) and from 0 cells/ml (site 4) to 18 721 cells/ml (site 2) respectively despite the size of the streams. The abstraction point of Midvaal Water Company (site 2) had the highest phytoplankton concentrations for all the taxa (classes) except for the Euglenophyceae which were most at site 1.

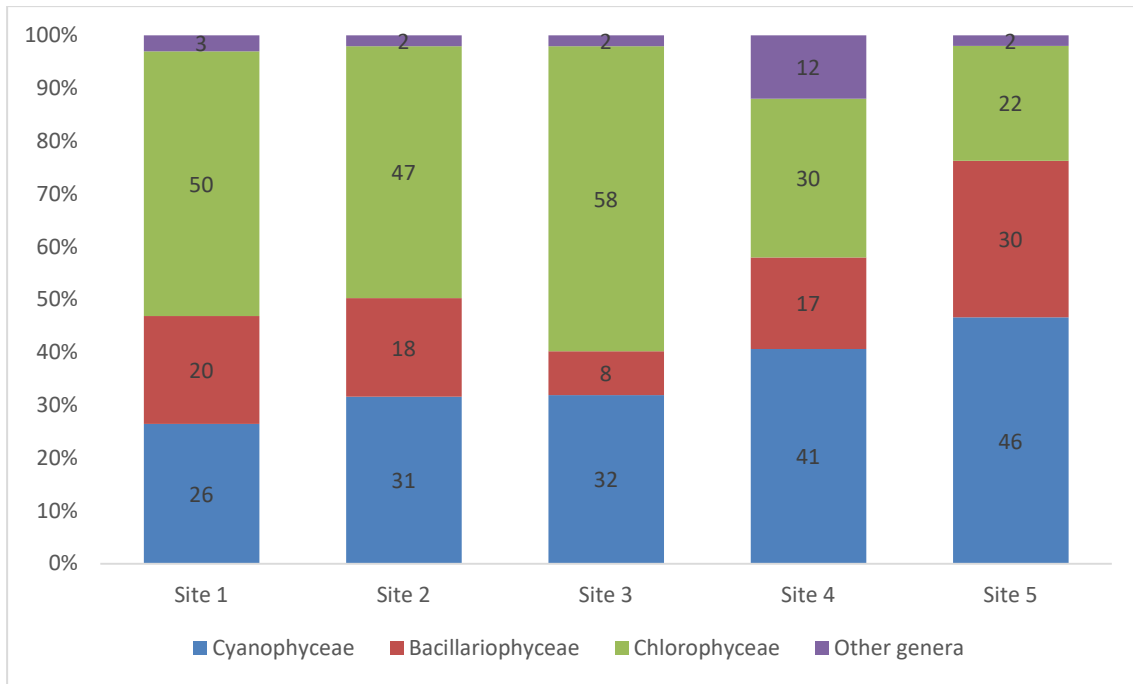
Figure 6-4: Taxonomic composition of phytoplankton samples collected from November 2012 to October 2014 at site 1 (Vermaasdrift Bridge), site 2 (Middle Vaal River), site 3 (Enviroclear overflow), site 4 (Koekemoerspruit before Enviroclear overflow) and site 5 (Koekemoerspruit after Enviroclear overflow)

The Chlorophyceae were dominant at sites 1 (50%), 2 (47%) and 3 (58%) while Cyanophyceae dominated at sites 4 (41%) and 5 (46%) (Figure 6-4). The percentage composition of the Cyanophyceae increased from sites 1 to 2 (26% to 31%) and from sites 4 to 5 (41% to 46%). Site 3 displayed the lowest Bacillariophyceae dominance (8%) and the highest Chlorophyceae dominance (58%) of all the sites.

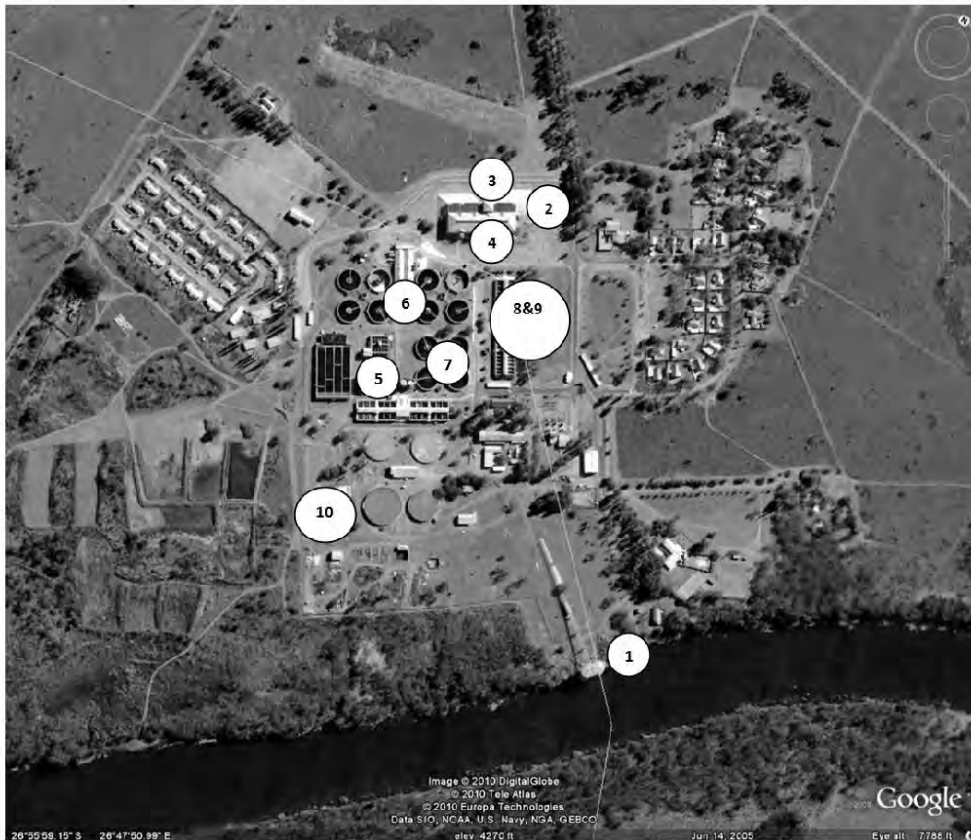
Figure 1

An aerial view of Midvaal Water Company. The treatment plant abstracts on average 130 ML /day, has a capacity to treat 320 ML /day and has a supply area that extends over more than a 1 000 km².

The study site is situated 14 km from Stilfontein, at 26°55'59.3" S and 26°47'51.8" E. Vaal River water quality data were available from 1984 and operational data were available from 2010. Water treatment at Midvaal Water Company currently consists of the following processes which have been implemented since 2007 (see Fig. 1 and Table 1):

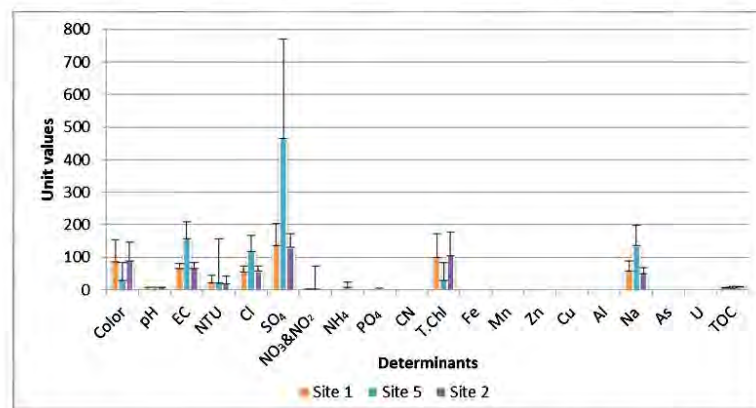
Figure 2. Mean values derived from the water quality monitoring data for sites 1, 5, and 2 from October 2002 to December 2015 ($n = 130 \pm \text{std}$); Site 1: Vaal River above the confluence of the Koekemoerspruit; Site 5: Koekemoerspruit before the confluence with the Vaal River; Site 2: Vaal River below the confluence of the Koekemoerspruit; EC: electrical conductivity; NTU: turbidity; T.Chl: total chlorophyll; TOC: total organic carbon.

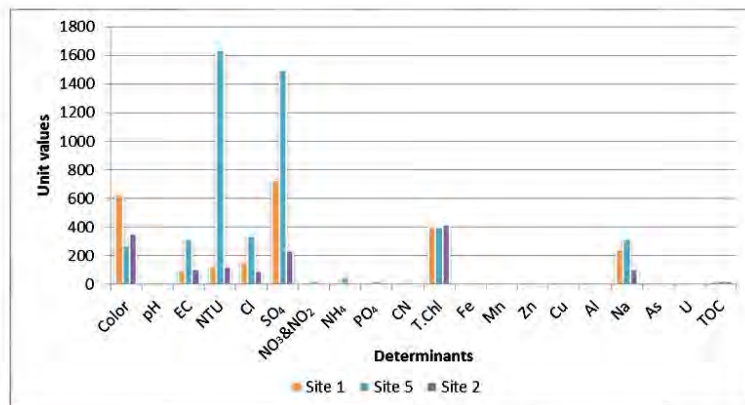
Figure 3. Maximum values derived from the water quality monitoring data for sites 1, 5, and 2 from October 2002 to December 2015; Site 1: Vaal River above the confluence of the Koekemoerspruit; Site 5: Koekemoerspruit before the confluence with the Vaal River; Site 2: Vaal River below the confluence of the Koekemoerspruit; EC: electrical conductivity; NTU: turbidity; T.Chl: total chlorophyll; TOC: total organic carbon.
