Chapter 5

RELAY OPERATIONAL ANALYSIS DURING FAULT CONDITIONS

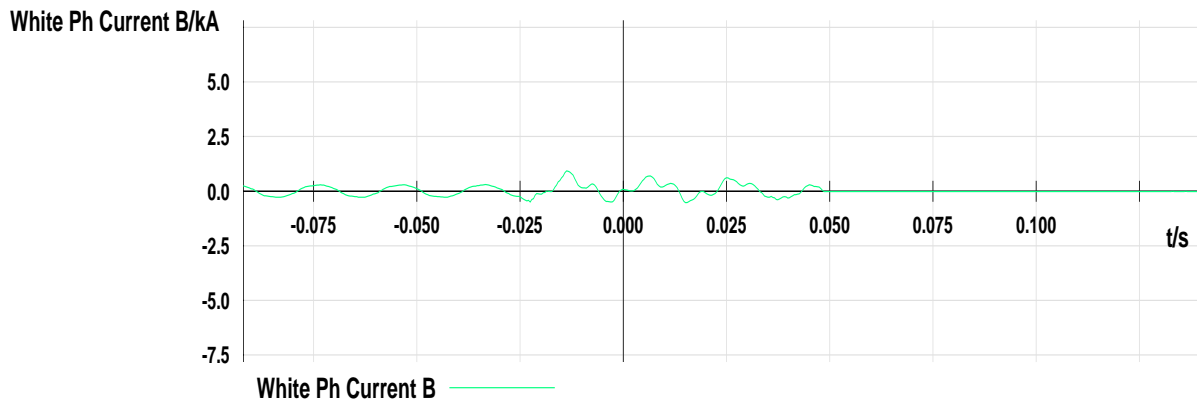
Figure 5.2: Current traces for Athene - Invubu incident

The actual fault event records together with digital event traces are graphically illustrated in Figure 5.1, Figure 5.2 and Figure 5.3. Figure 5.1 depicts the three-phase voltage traces prior, during and after the fault, while Figure 5.2 represents the current traces for the same period. The blue-phase shows a major reduction in voltage indicative of a low resistance fault not far from the position of measurement. The current traces are somewhat misleading as a distinct relationship can be observed between the blue-phase and neutral currents, which are in phase and of similar magnitude, indicating a phase-to-earth fault. A significant increase and severe distortion of the red and white-phase currents occurred. This line is short, only 21.85 km long, which will result in this type of voltage depression on the faulted phase for faults towards the end of the line or for resistive faults.

It was concluded that the busbar fault could only have been the cause of a gas leak in the specific chamber resulting in insulation breakdown. It was also concluded that this was the root cause for the Athene – Invubu feeder trip. The resultant arcing inside the combined three-phase chamber was then also determined to be the reason for the distortions recorded on the red and B-phase currents.

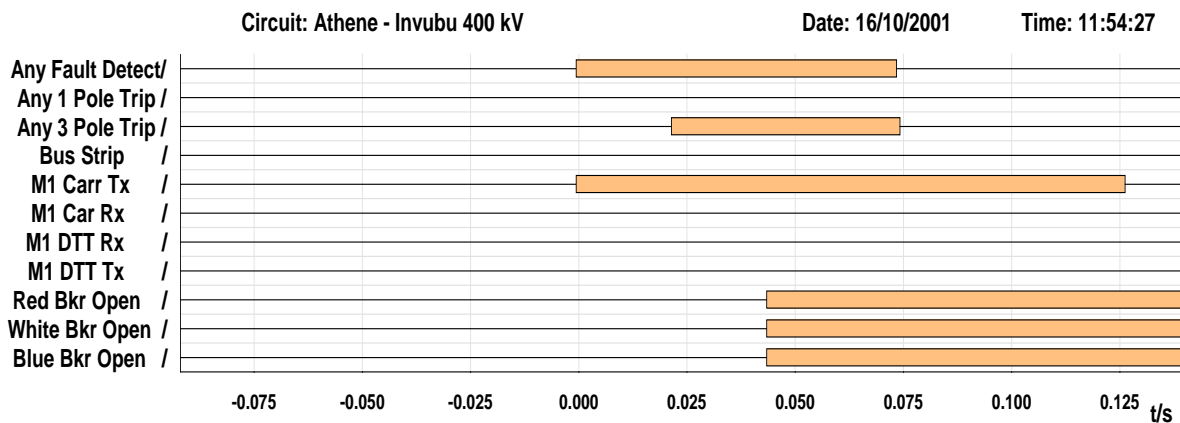
Figure 5.3: Digital traces for Athene - Invubu incident

The digital traces revealed that the fault was originally detected as a single-phase-to-earth fault, which developed into a resistively coupled three-phase fault after approximately one-cycle, with an overall clearing time just exceeding 73.85 ms. The recording therefore shows that the Athene – Invubu feeder tripped within the instantaneous time frame confirming that the relay’s zone 1 element overreached the total line length. Figure 5.4 shows the impedance locus at the time of fault superimposed on the relay characteristic in the positive sequence plane. The relay’s reach clearly extended to the point of the fault. The actual reason for the relay’s zone 1 overreach was not known.

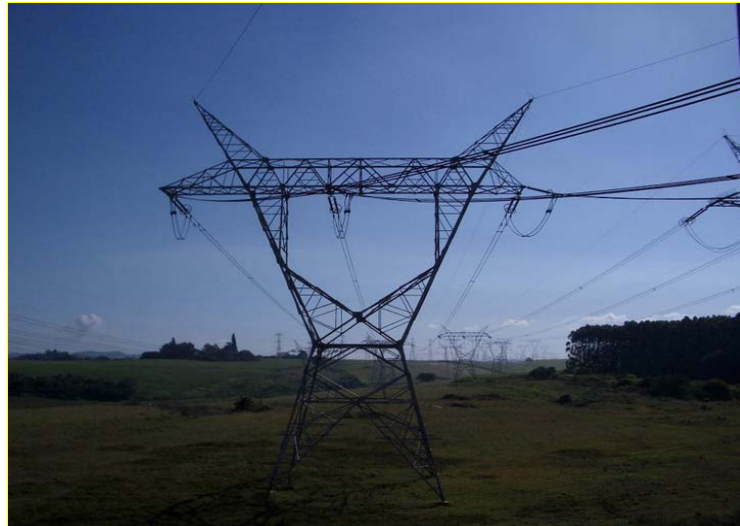
Figure 5.10: Tower 1 near Athene substation [15]

The Athene-Invubu line has an overall length of 21.85 km and consists of two sections each with a different tower construction. Figure 5.10 gives an impression of the first tower on this line from Athene substation. Tower type 515 is used on the first 7.062 km and type 510 on the remaining 14.787 km, whilst the whole line is strung with twin dinosaur bundle conductor with 450 mm spacing. The earth-wire was given as stranded steel wire in the TxSIS database.

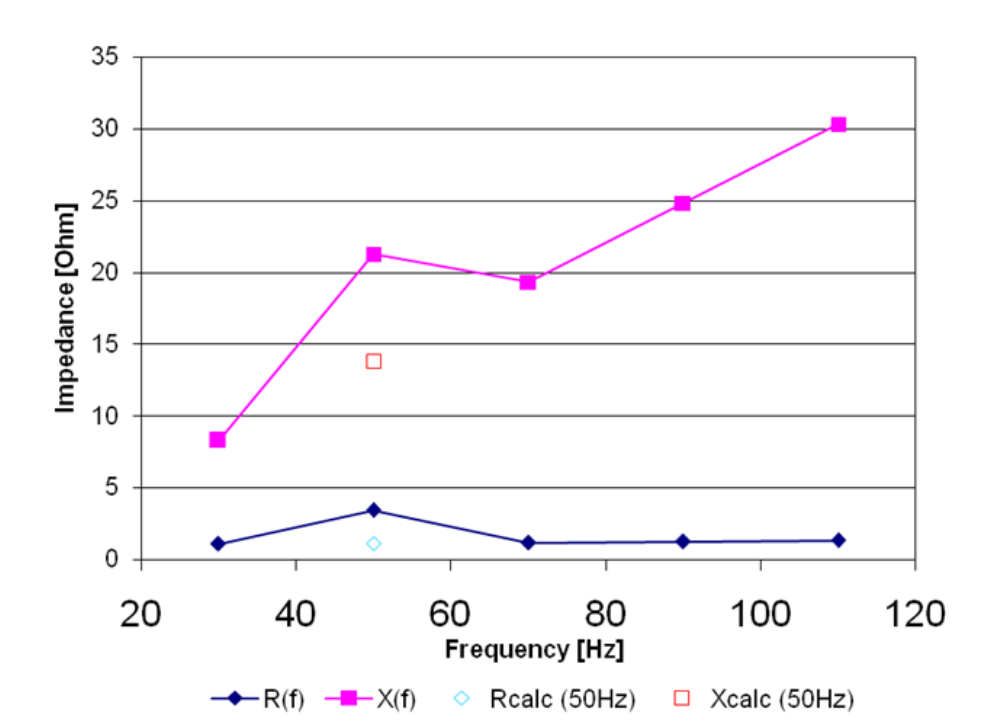
Figure 5.11: Frequency response of resistance and reactance [15]

The line impedance was measured in June 2004 at 30 Hz, 50 Hz, 70 Hz, 90 Hz and 110 Hz to determine the linearity of the resistance and reactance measurements. The results of these tests are depicted in Figure 5.11. The deviation in resistance as well as reactance due to interference from the surrounding in service overhead lines is clearly visible for the 50 Hz test results. The corrected calculated values, as determined from the other frequencies are also indicated on the same graph [15].

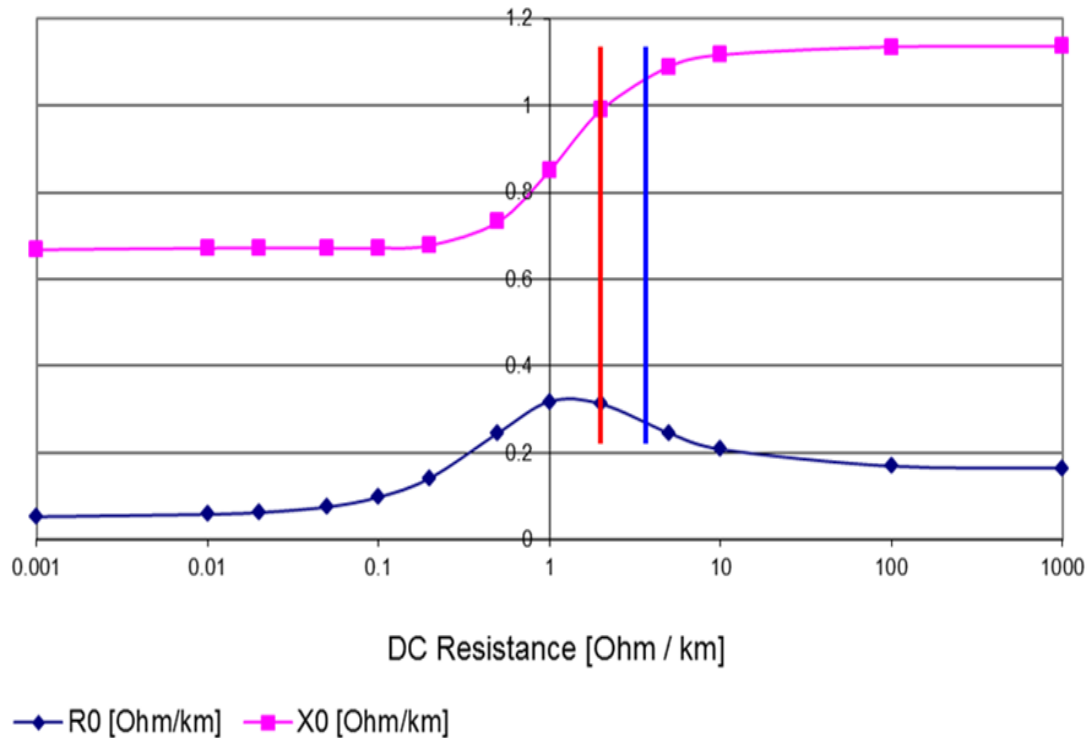
Figure 5.12: dc-resistance sensitivity analysis [7]

The result of this analysis is depicted by the curves shown in Figure 5.12 indicating the relationship between dc-resistance and zero-sequence impedance of a typical EHV line [7]. From Figure 5.12 it can be observed that for an earth-wire conductor dc-resistance of between 0.1 Ω/km and 10 Ω/km the zero-sequence resistance (R_0) and inductance (X_0) varies significantly. This is a very important observation, since typical values of dc-resistance for different types of conductors used fall in this range. It therefore follows that should an incorrect dc-resistance value for the earth-wire conductor be used to calculate a specific lines impedance values, a significant variation from the actual line zero sequence impedance could result.

Figure 5.12 shows that for specific values of dc-resistance, the zero sequence resistance actually decreases, whilst the zero sequence reactance increases rapidly. This phenomenon is therefore thought to be the reason for the differences that exist in the final result comparison.

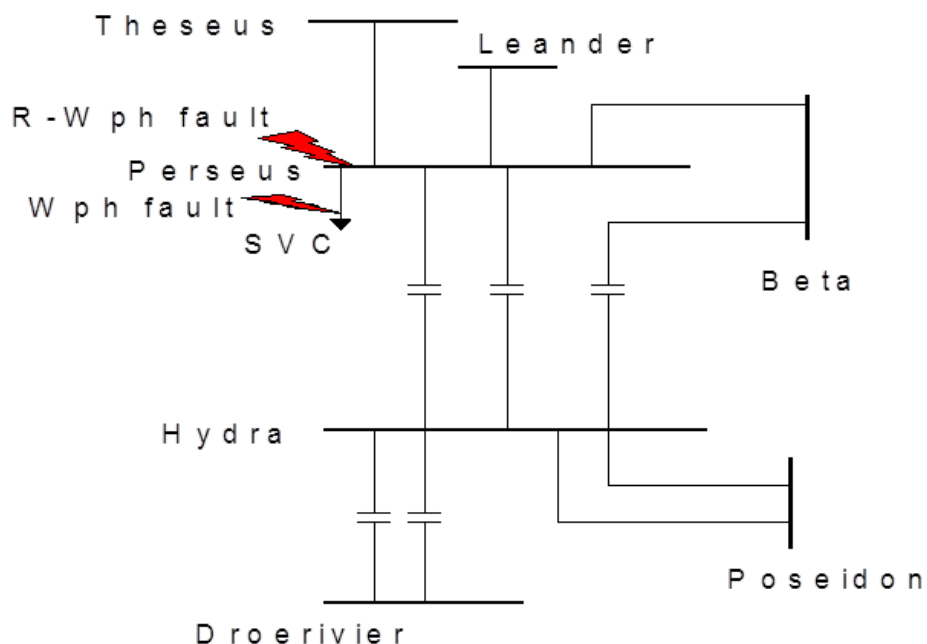
Figure 5.13: Network interconnectivity diagram

The Hydra – Perseus and Leander – Perseus feeder protection overreached resulting in incorrect tripping and auto re-closing of these 400 kV feeders. This section will focus on the Hydra –Perseus line, which tripped on B-phase in zone 1 reach and re-closed. Hydra and Perseus substations form a very important link in the Eskom transmission power grid in that it interconnects the generation in the north to Koeberg in the south. Loss of this connection due to a system fault could result in severe system instability due to the imbalance created between power generated and demand. The interconnectivity between these two stations is shown in Figure 5.13.

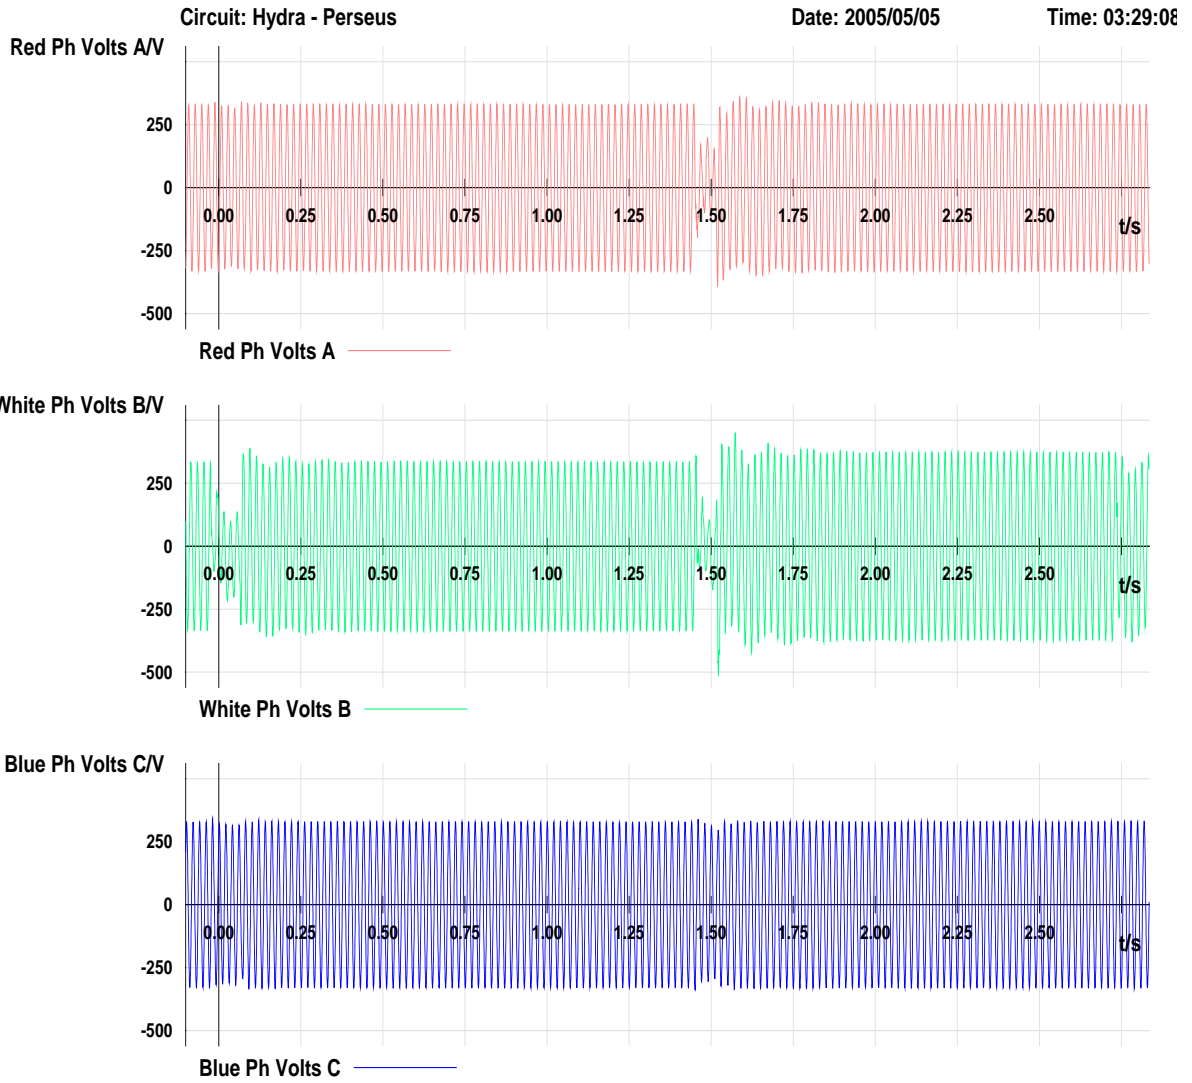
Figure 5.14: Voltage traces for Hydra - Perseus fault

to-earth fault caused by the failure of the 400 kV Static Var Compensator current transformer was cleared in 90.6 ms by its own protection. The voltage traces in Figure 5.14 shows two white-phase voltage dips, similar in magnitude. The Hydra – Perseus circuit did not trip for the first instance as is also indicated by the binary signals in Figure 5.16. The second fault, which was caused by the A-phase to B-phase busbar fault, was cleared in 68.23 ms. The protection on the Hydra – Perseus circuit incorrectly operated for the red-to-white-to-earth fault. From the binary traces in Figure 5.16, it can be seen that the B-phase current returns after approximately 1.25 s, whereas the normal dead time for a single-phase auto-re-closure is 1 s, showing an additional delay.

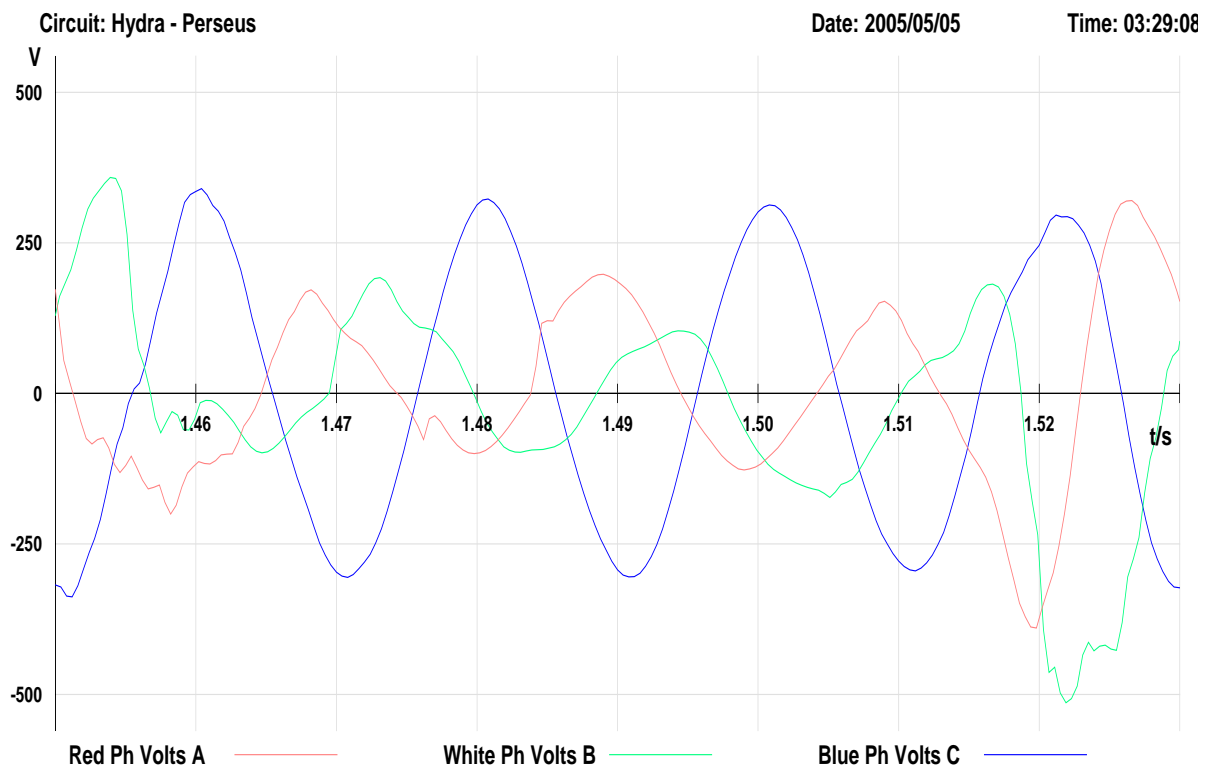
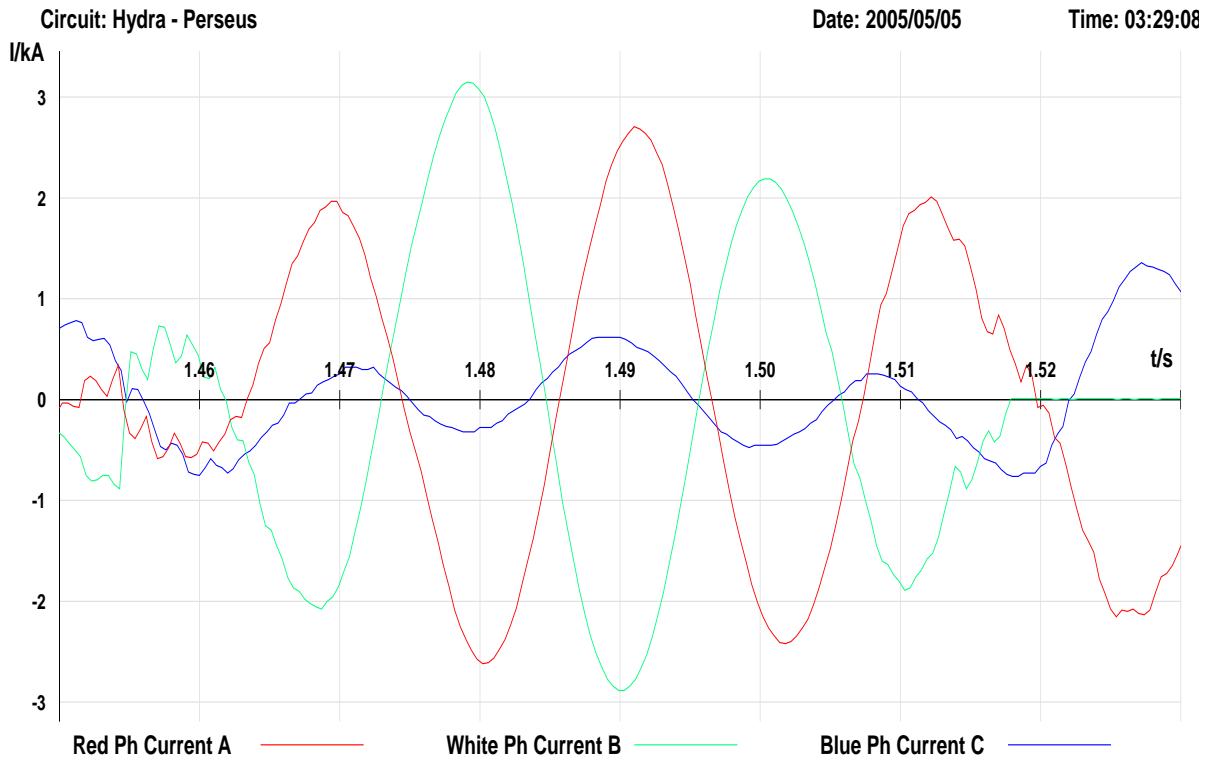
Enlarging the second fault portion of the voltage and current traces to enable greater observability results in the graphs shown in Figure 5.17 and Figure 5.18. From the voltage traces can be observed that some harmonic distortion was responsible for the non-sinusoidal waveform during the fault. The A-phase and B-phase current traces show a fair amount of harmonic distortion at fault inception and during the fault. Figure 5.19 graphically illustrates the impedance locus of the B-phase (Z_{bg}) at the time of fault. The extent of overreach for this fault on the Perseus busbar is shown in Figure 5.19.

Figure 5.17: Enlarged voltage traces for Hydra - Perseus fault

Figure 5.18: Enlarged current traces for Hydra - Perseus fault

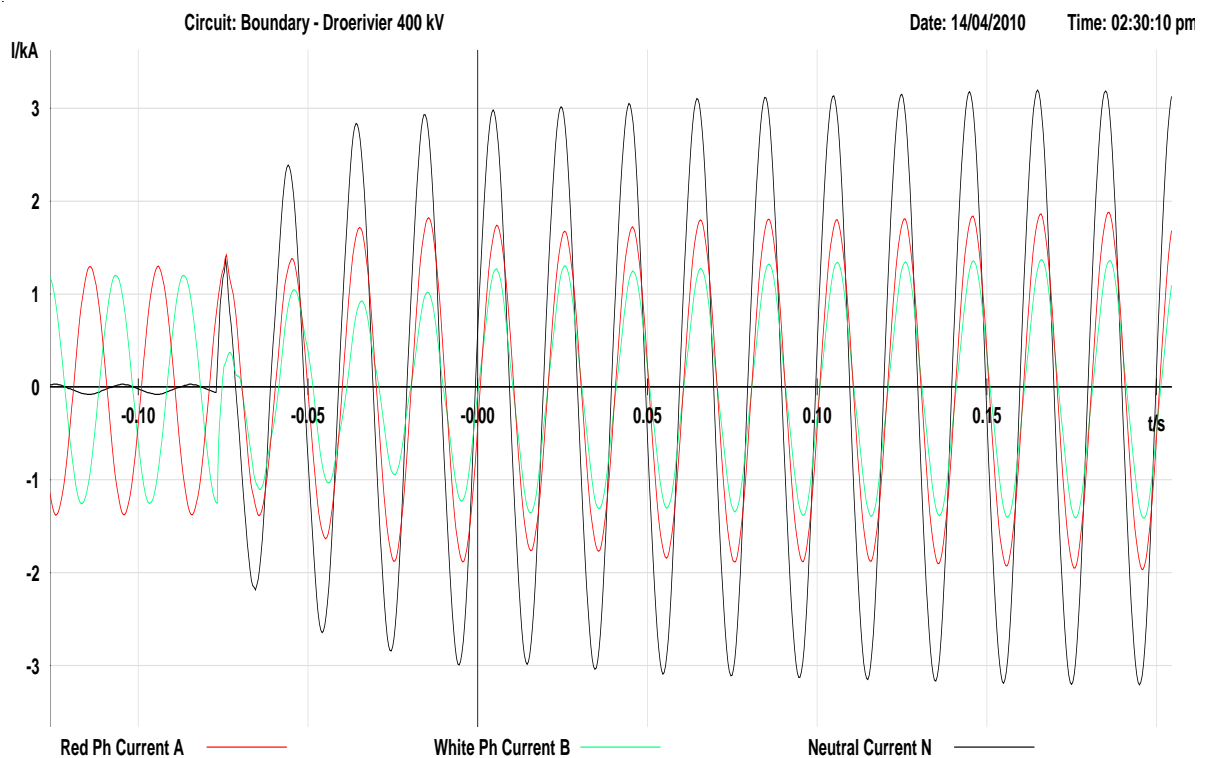
Figure 5.33: Superimposed fault currents on Bucchus - Droërivier feeder

For the purpose of this document we will focus on the events at Bacchus substation only. Superimposing the red, white and neutral currents reveal that all three currents are almost perfectly in phase during the fault, indicating that in fact a red-to-B-phase-to-earth fault occurred, with the A-phase current being the more dominant phase current.
