# *Geographic information systems based demarcation of risk zones: the case of the Limbe Sub-Division – Cameroon*

**Buh Wung Gaston**

GIS/RS Officer

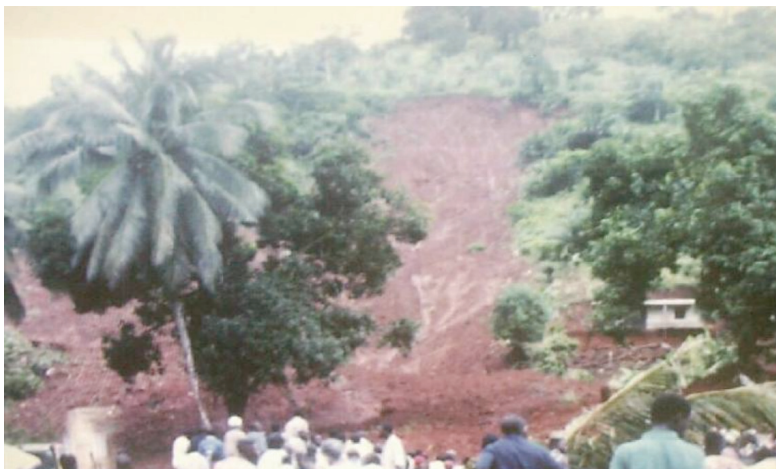
***Photo 1: Mabeta new layout, landslide, 2001***

The Mabeta-1 landslide of June 2001 was the biggest and most disastrous landslide. Over 100,000m<sup>3</sup> of soil turned to mud by rain and ground water was displaced in a quasi North-South direction for some 250m. From the line of surviving houses on the western side of the scarp, it was noted that furthest up-slope houses were located at about 108m altitudes.

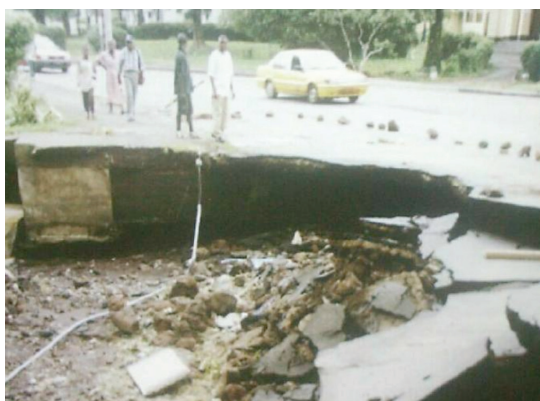
**Photo 2: Flood-effect collapsed portion of tarred road in Limbe**

Further downstream, the riverbanks are now more extensive, the floodwaters have spread out and the width reaches 100m in some places during raining months. Large boulders, some measuring 1.8x1.3x1m torn are brought from the hills, including large tree trunks which dropped because the water current reduced on spreading out in the low- lying flat valley. Though houses are usually destroyed and a lot of property lost. In August 1989, flood caused damage to property but no human casualties were reported (Agingy-personal communication, 2005). Casualties were reported from the floods of June 2001 (At 4o 00.90'N, 9o 13.89' E,) up stream, where two small landslides occurred near the head of the natural drainage course into a deep narrow ravine carved through the thick soil mantle down to a compact basaltic lava flow. Tar-marked road collapsed at 2 localities at Down Beach Quarters due to the flood. Close to the Provincial office of Public Works at 4o 00.30'N, 9o 12.61' E, about 140m<sup>3</sup> of tar-marked road was broken (Aka, 2001)

Near Mbonjo Beach Inn junction at 4o 00.19'N, 9o 12.69' E, 320m<sup>3</sup> another portion of the same road collapsed. Concrete power supply poles were destroyed. Seawater wave front positions were observed 40m from the road along which the broken roads occurred. Houses collapsed and casualties were reported during the 2001 incident in several areas in the city of Limbe.
