## **CHAPTER 2**

### **DATA**

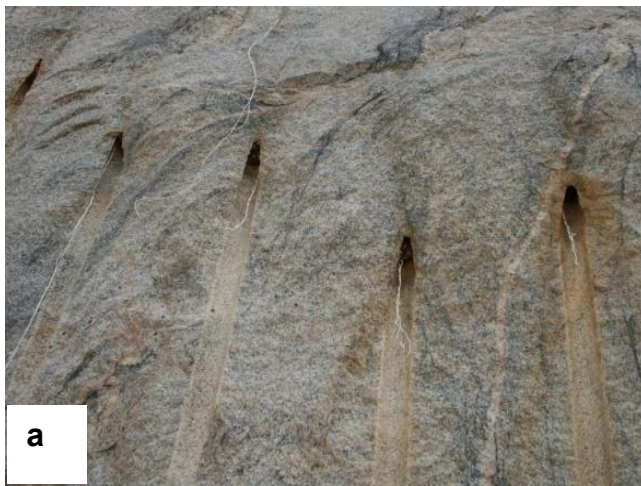
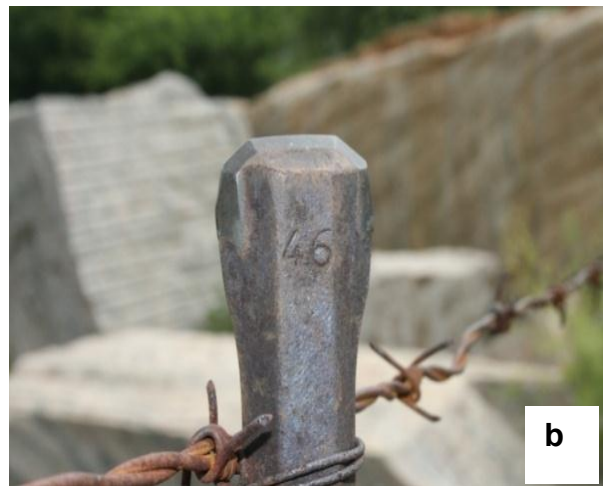
In some cases leftovers of ignition cord and jumper rods are still visible in the drill holes (Figure 43a and Figure 43b).

Figure 43. (a) Ignition cord used to ignite dynamite candles, still dangling from drill holes at the GQ8 quarry on Kopjeskraal 157 and (b) jumper rods, used to do percussion drilling, still visible in some drill holes at the same quarry.

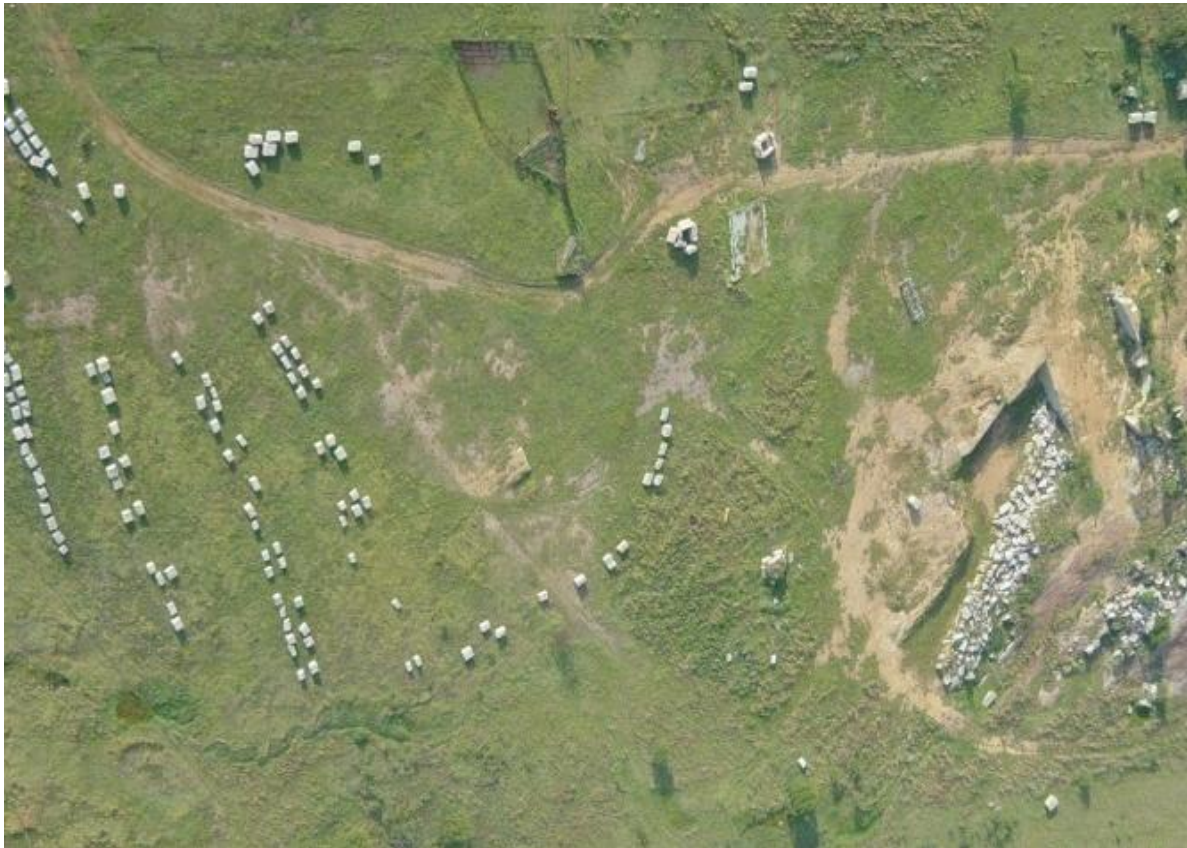
Due to the listing as a WHS, no further mining of the quarries are allowed. The last blocks of precious granite from these quarries are being transported to locations country wide and cut locally by the third generation Mr Angelo Pedretti. Blocks, unsuitable as ornamental stone, are left scattered around quarries amongst the rubble and mine dumps (Figure 44).

Figure 44. Scattered unused granite blocks around a quarry GQ12 photographed from a hot air balloon.

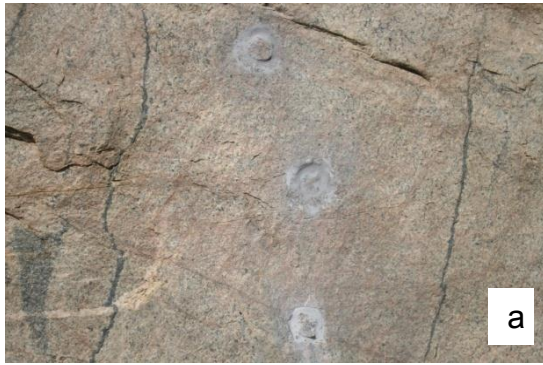
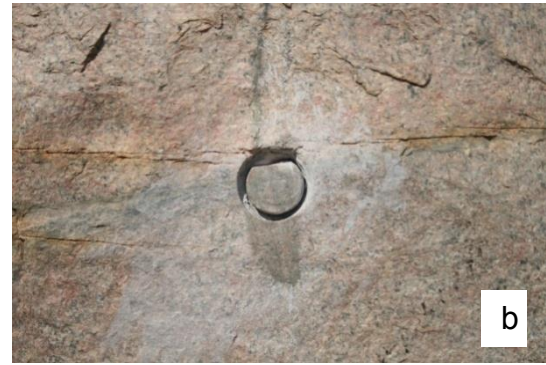
The quarry walls display evidence of geovandalism where recent diamond drilling samples were taken, presumably for research, but later returned and cemented back in place (Figure 47a and b). At least this is the first known case where a mistake was acknowledged and an attempt made to correct it. Perhaps a lesson can be learned here by all geoscientists.

Figures 47a and b. Scientific researchers start to heed the concepts of conservation when the cores of diamond drilling were returned and cemented back in the quarry wall at Salvamento.

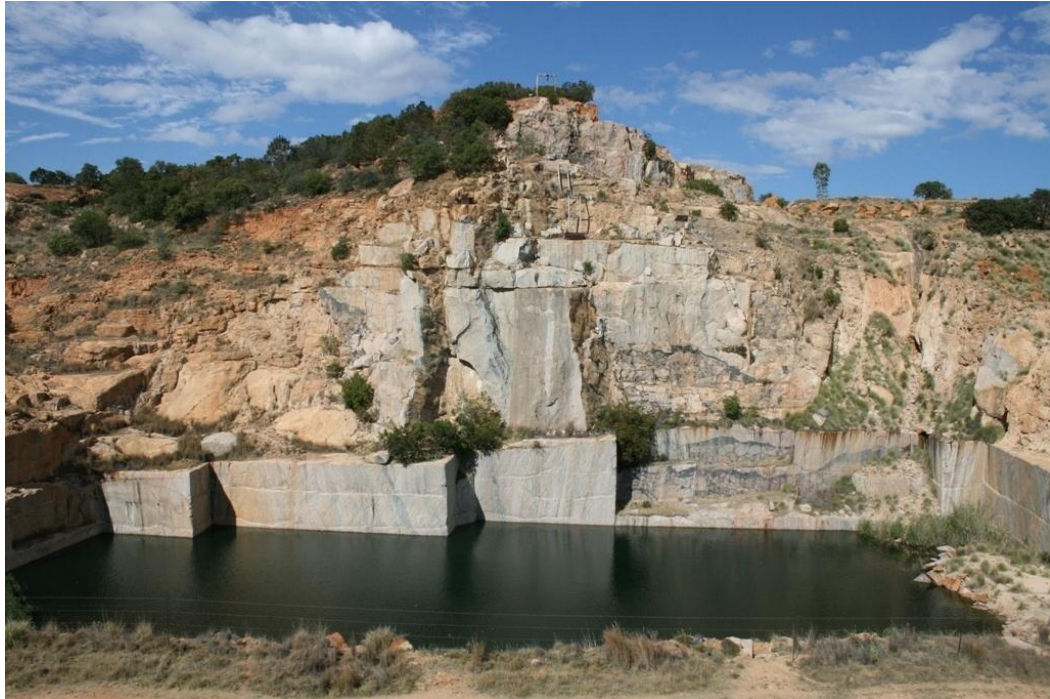
The risk profile is very high here as up to 50 meter vertical pit walls with unstable rock dumps exist. Erosion holes and channels exist on the northern rock dump. A tour

Figure 48. At Leeukop Quarry, the exfoliating granite pluton resembles a lion's head when viewed from the north. A very impressive pseudotachylitic breccia vein is exposed along the quarry face. This photograph illustrates how the quarrying contributed to the visualization of the three dimensional shape of these veins, something that would not have been possible on this scale without quarrying the Parys granites.

Since the end of mining, erosion and degradation have resulted in serious safety conditions in most quarries. The risk associated with unstable rock dumps and overburden is visible at Leeukop Granite Quarry (Figure 63).

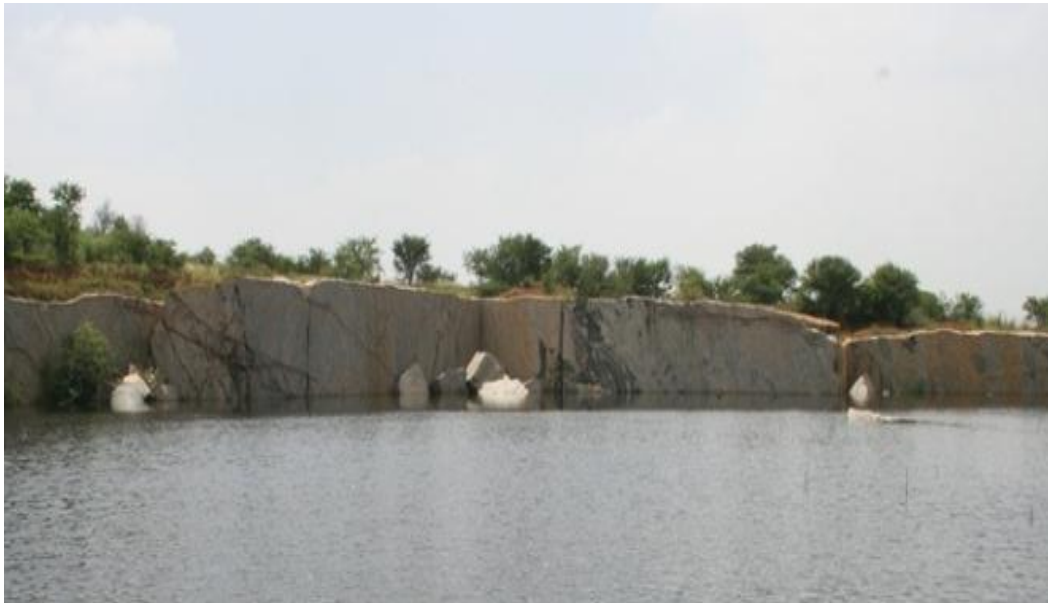
The Rietpoort Quarry has high vertical pit walls and is water-filled (Figure 49). This quarry has dangerous rock dumps with erosion holes. Attempts at construction of a road on the rock dump by capping of the rock dump are visible where soil was used as superficial cover. This has resulted in dangerously deep erosion holes forming in the dump along with unstable ground conditions. Unused blocks were used in the construction of a dam wall.

Figure 49. The Rietpoort Quarry, GQ4, with vertical walls and filled with water (Rietpoort 518).

It is recommended that an urgent risk assessment be done as there are currently tourism activities on this farm.

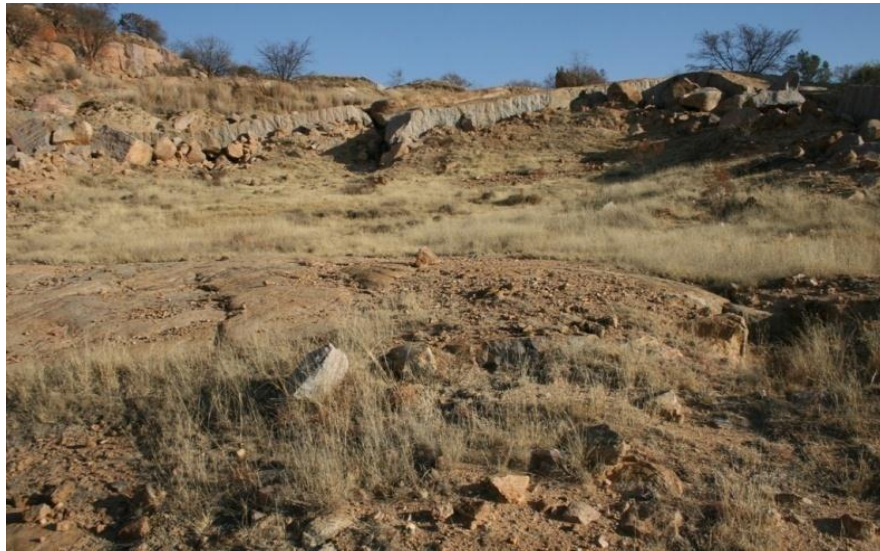
This quarry was mined by Marlin Quarries operations (Mario Pedretti). Rehabilitation efforts resulted in the quarry face being partially filled in with rubble. This now poses a safety risk as erosion holes occur in this area (Figure 50). There are also two very high rubble rock dumps with steep slopes (Figure 51).

As a result of the unsuccessful rehabilitation effort, infilling used resulted in unstable ground conditions rendering this quarry unsuitable for tourism.

Figure 50. The quarry face at GQ11 (Rensburgs Drift 432) having been filled in with rubble.

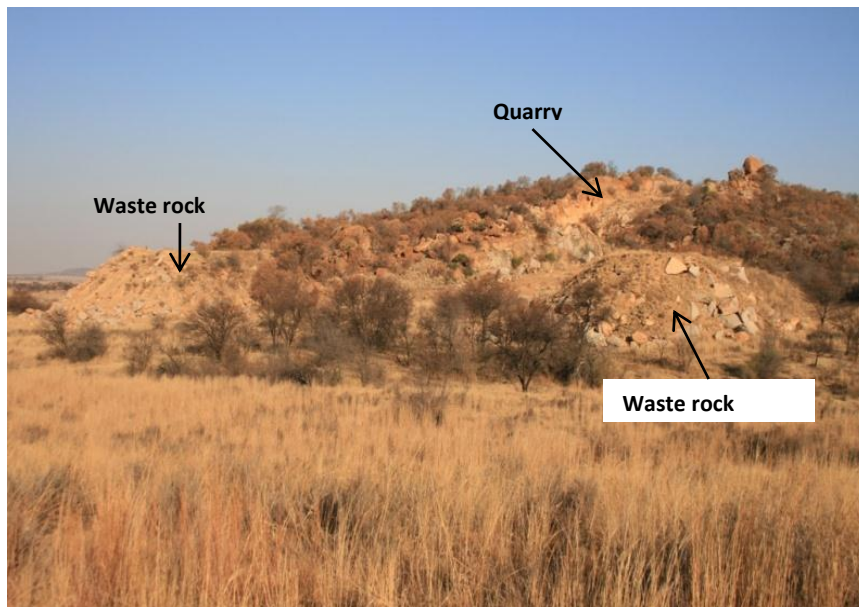
Figure 51. A distant view of the Rensburgs Drift Quarry, GQ11, with the two rock dumps.

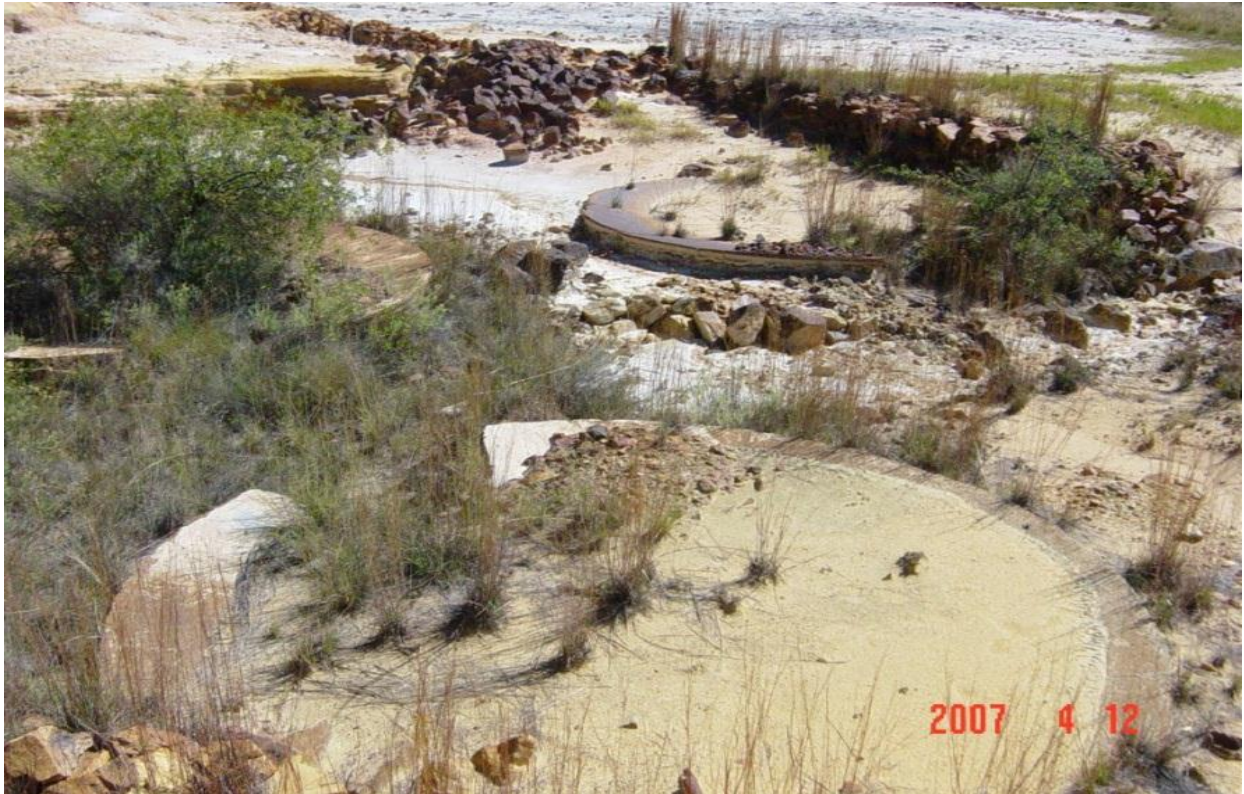
In the case of unoxidized ore it was treated with a cyanide process. Foundations of the cyanide leaching bins are visible from the Great Western and Colin Voi Mines (Figures 55 and 56).

Figure 55. Cyanide bin foundations at the Great Western Mine, E1, Elandslaagte 28.

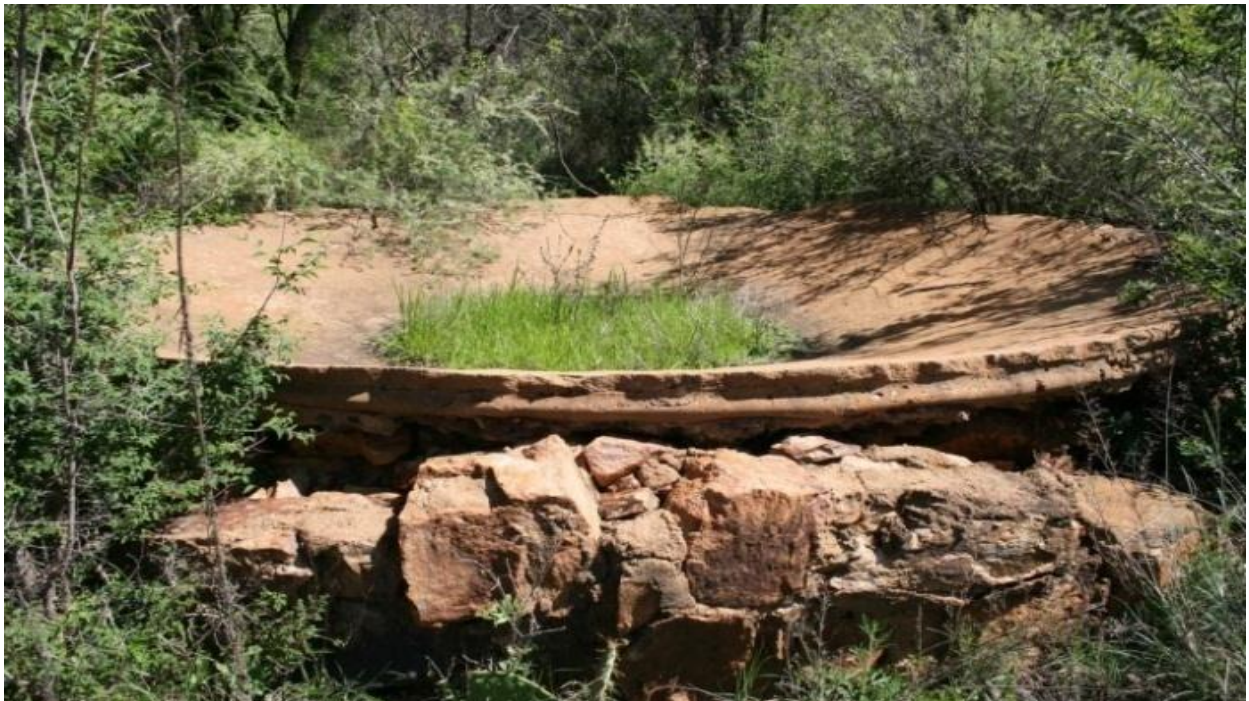
Figure 56. Similar cyanide bin foundations at the Colin Voi mine, N1 on the farm Nooitgedacht 89.

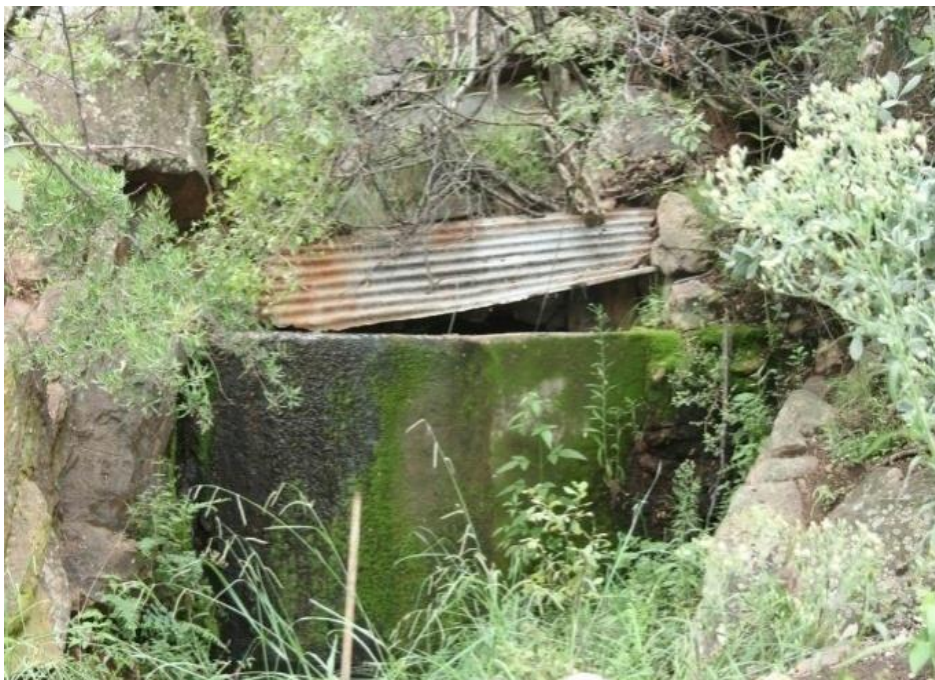
At one mine site, KF1 at Koedoesfontein 478IQ the adit entrance has been partially closed (Figure 71). The result is that rain and groundwater fill up the underground development forming a large reservoir of contaminated water due to acid rock drainage. The water has been used in the past to water a vegetable plot and is currently the source for water for cattle. It is also a very reliable source of fire fighting water high up in the mountains next to the fire-fighting road established in 2008 by the North West Department of Agriculture.

Figure 71. Mine adit KF1 at Koedoesfontein 478IQ partially closed for water extraction.

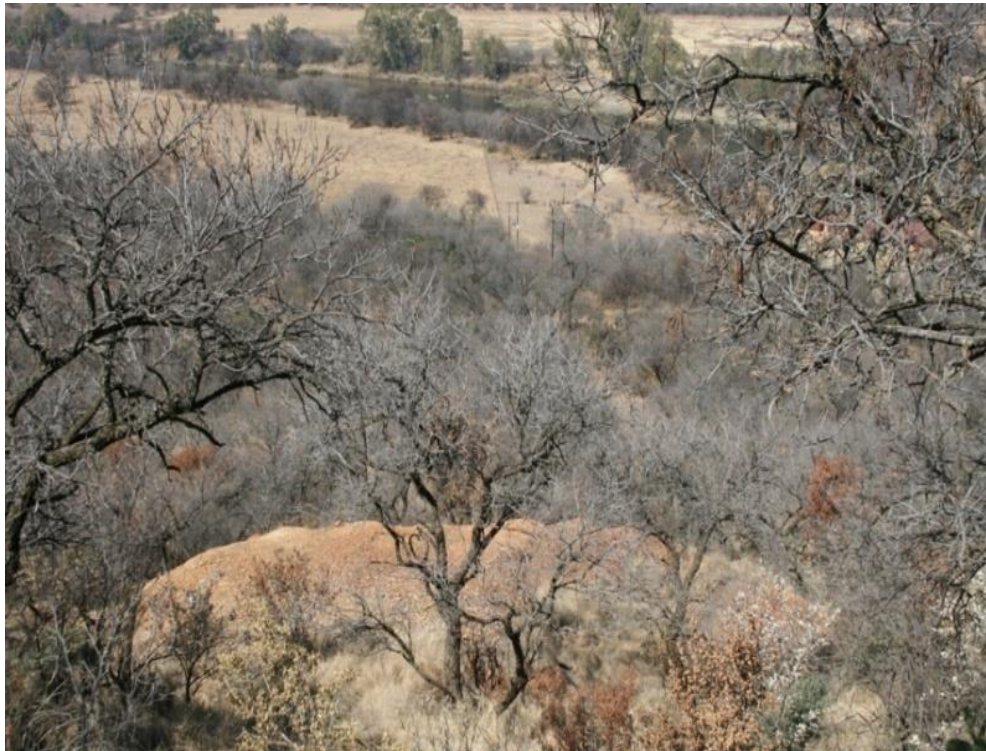
At Rooderand 510IQ (RO1) (Appendix C), the rock dump is not more than 300 m from the Vaal River (Figure 74) and probably produces AMD which could find its way to the river.

Figure 74. The rock dump on Rooderand 518IQ, RO1, with the Vaal River visible in the background.
