## **CHAPTER 3**

### **DISCUSSION**

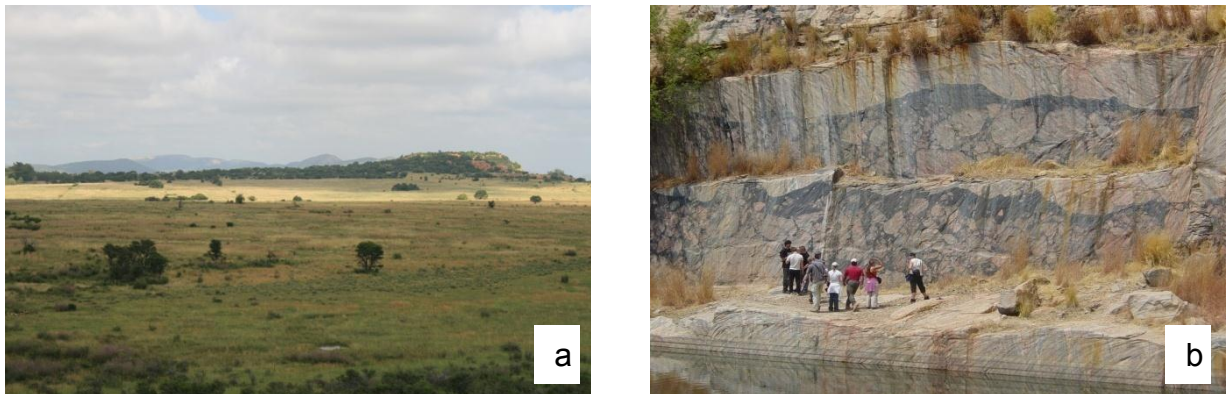
Figure 75. (a) In the distance on the right hand a granite pluton can be distinguished above the flat plain. In (b) so much more can be observed regarding the petrography, the effect of a meteorite impact, as well as the effect of recent weathering on freshly exposed rock surfaces.

The term “geodiversity” has been used from the 1990s to describe the variety in abiotic nature and more recently, Prosser (2002) used this concept as a means of promoting geoconservation. The conservation of the Vredefort Dome’s geodiverse sites is important to protect the diverse variety of rock types, and geological events spanning geological time from the Archaean Eon at approximately 3500 Ma to Karoo times of 65 Ma. The mines and quarries allow for a clearer view and understanding of these complex assemblages of igneous, sedimentary and metamorphic rocks. This is evident when comparing the view of a commonly outcropping granite pluton against the sight and information on display at a site following partial mining (Figures 75 a and b).

At the Leeukop Quarry a rich geoheritage is visible following mining of the quarry. This two- and three dimensional presentation of the pseudotachylitic breccia would not have been available had it not been for the quarrying. Conservation allows natural processes to operate and natural changes to occur. This implies that a weathered road cut can be allowed to continue weathering, thus exposing new fresh surfaces while incorporating the weathering factor and making the visitor aware thereof. Human action has often

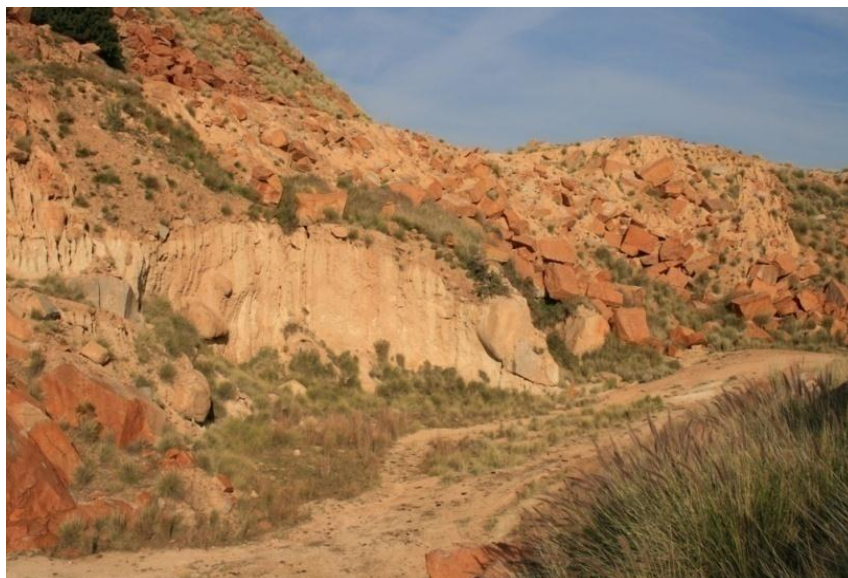
Geoconservation may include efforts to make a site more appealing to the visitor's eye. In Figure 76 these granite dimension stone blocks and fragments were stained in an attempt to do just that. In the scope of geoconservation, geoheritage and geotourism this effort is questionable as it is unnatural in colour, difficult to apply consistently and probably not environmentally friendly. It also obscures the rock surface for proper viewing by the visitor.

Figure 76. Granite blocks at Leeukop Quarry (GQ3 Kopjeskraal 517 IQ) are stained with an iron oxide in an attempt to blend the freshly exposed granite with the natural environment.

Rehabilitation at the granite quarries should be considered with care. The remains of stained excavated blocks bear testimony to earlier attempts to restore the site. However, with a more focused visit to the site the attempt seems obviously distracting to visitors. Some of the rubble material provides excellent viewing decks to the environment even though it is riddled with erosion trenches. The rubble also provides a resource for sample collecting. Drainage systems are recommended to deter run-off water which causes erosion. In some instances such as at Salvamento quarry, vegetation that obscures a special quarry face with excellent exposures of pseudotachylite should be removed.
